South Platte River Restoration Master Plan

Prepared for:
City of Evans, Colorado

Prepared by:
CDM Smith

Appendix A

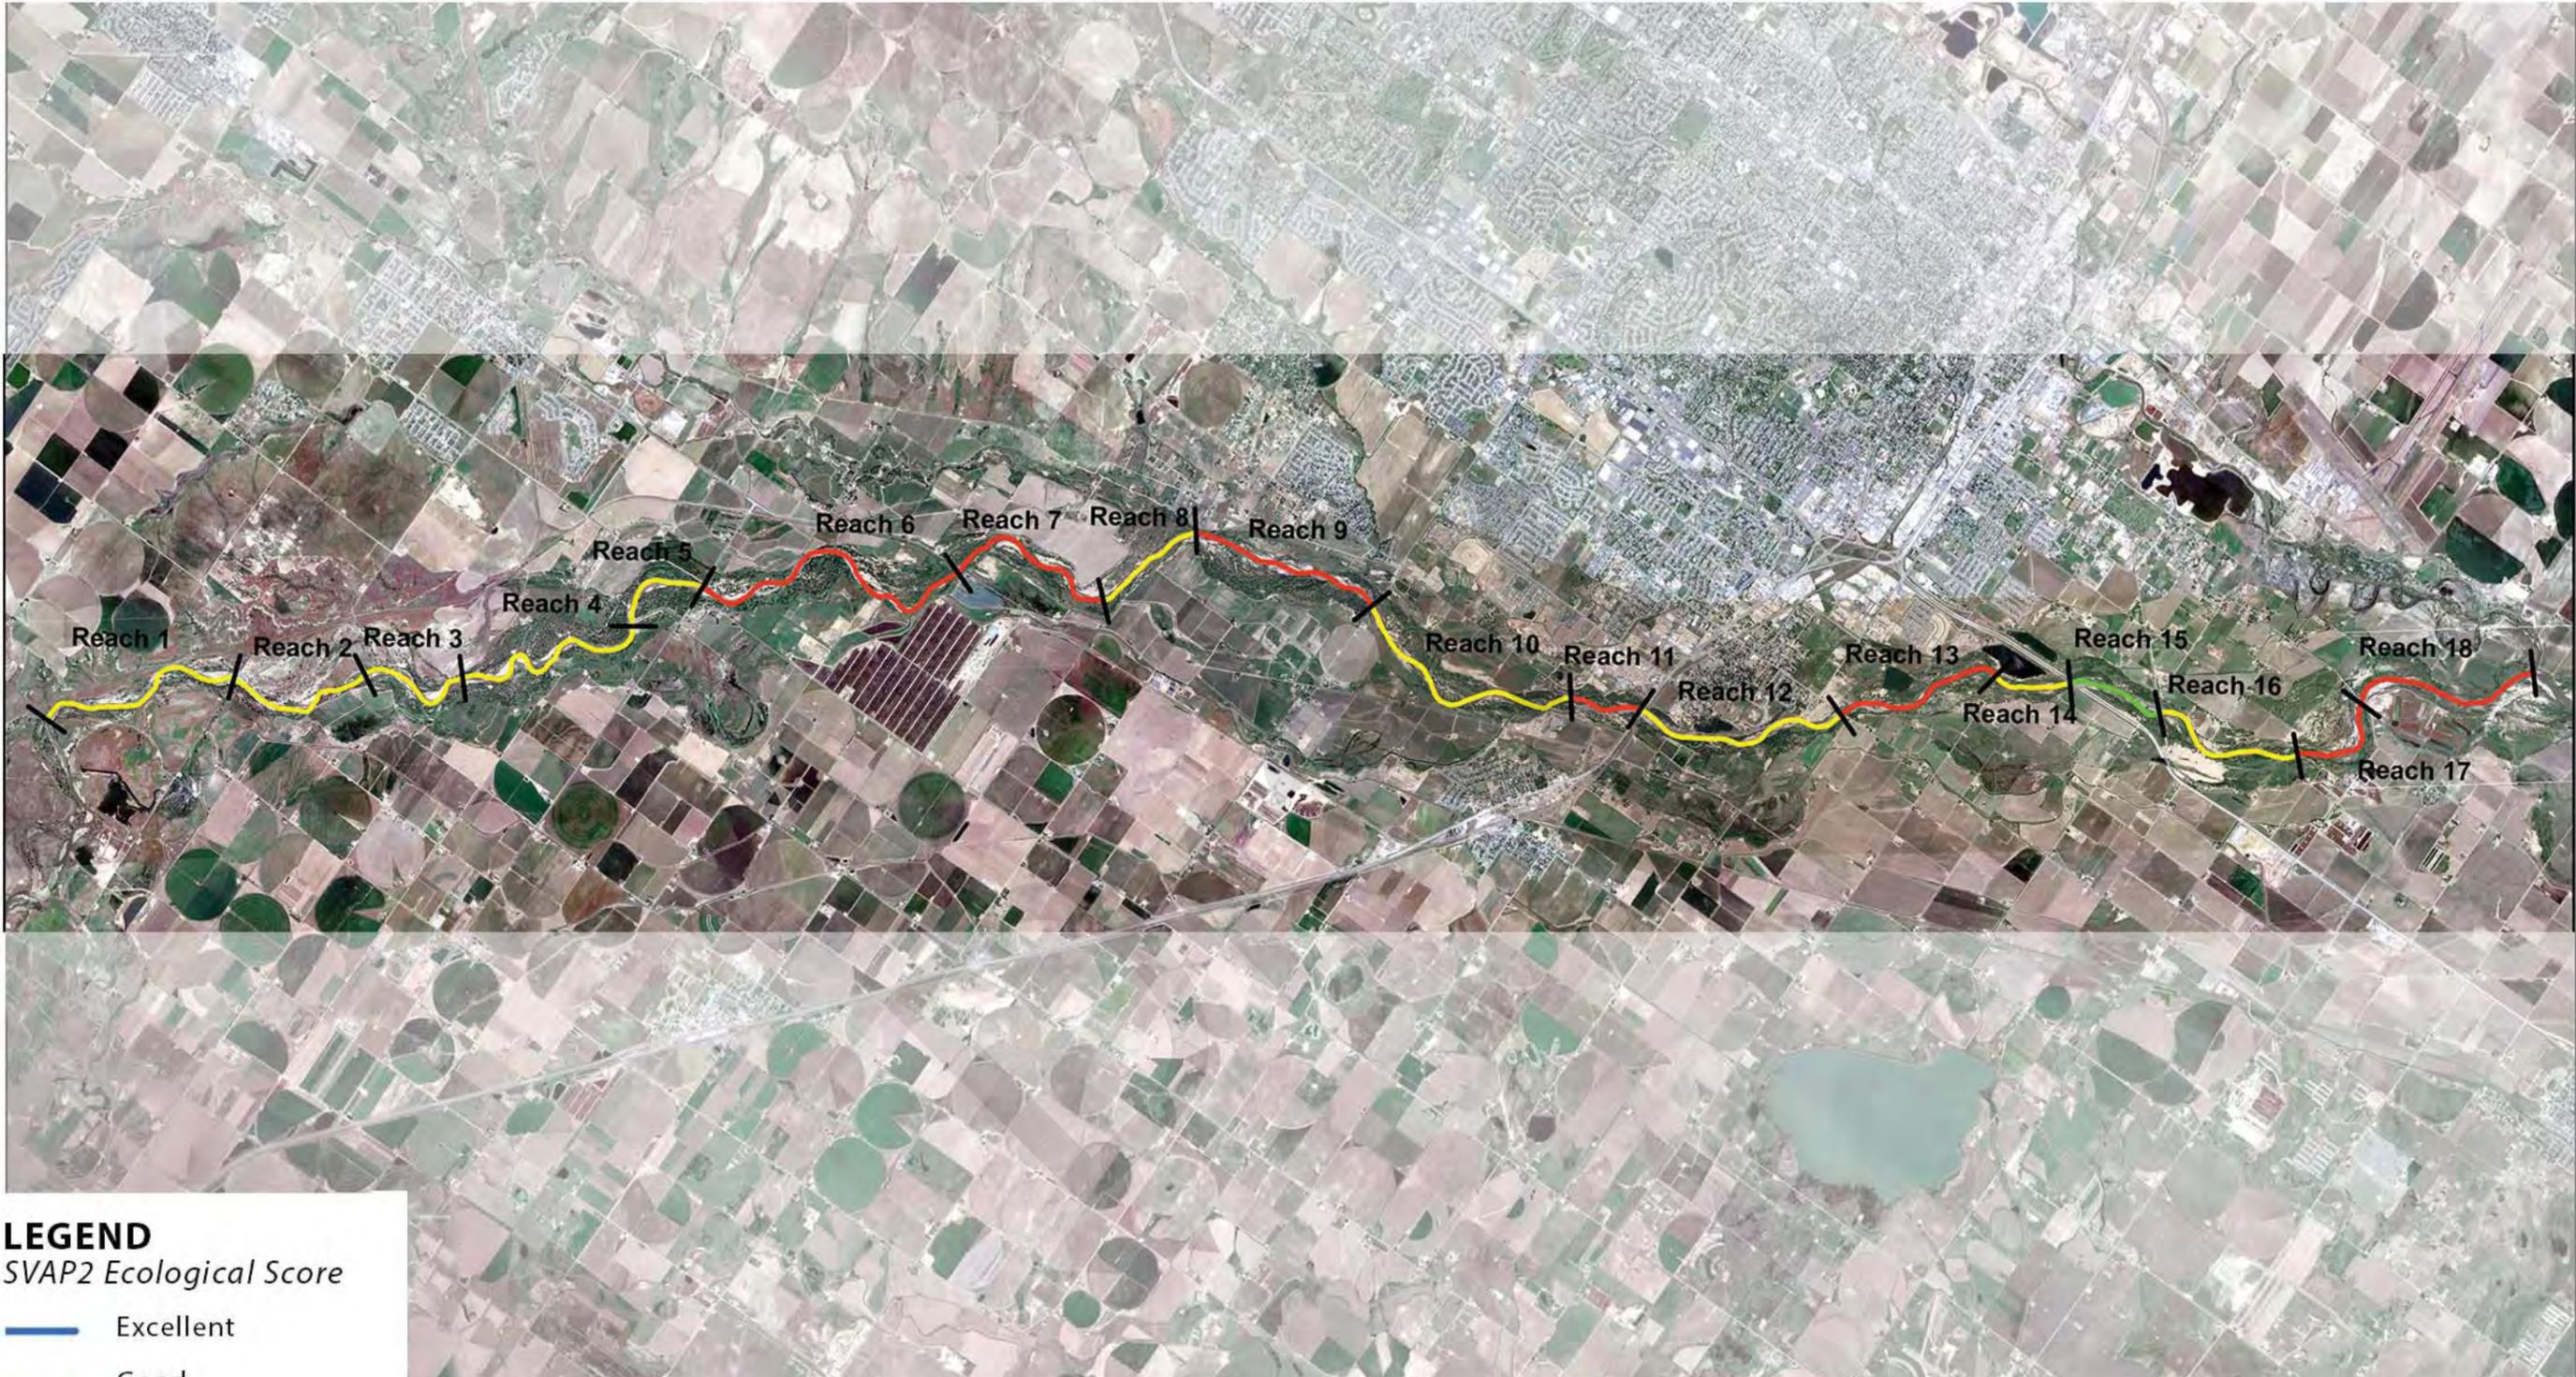
The majority of the 18 reaches were rated as severely degraded and poor, with exception of Reach 15 which rated fair (Figure 5.1). Overall, the South Platte River channel is highly modified with large portions of the river bank failing. Steep banks are falling into the stream and widening, which creates point bars and deposition within the active channel. There are very few locations where there is connection to the floodplain. On average, the riparian area is fairly wide; however, there are large gaps in the vegetation along the stream bank, which decreases the riparian quality rating. The overall riparian quality through the study area also rated low due to the lack of cottonwood and willow species regeneration. Additionally, there were significant concentrations of invasive plant species present. Water quality within the study area is negatively impacted by land use practices adjacent to the river. Surface runoff from agriculture and industrial sources promote excessive algal and plant growth. Habitat for aquatic species lack diversity within the study area, and the presence of irrigation diversion structures also impact the movement of aquatic species. Reaches 1, 2, 4, 5, 10, 14, 15, and 16 rated as a medium ecological risk, while reaches 3, 6, 7, 8, 9, 11, 12, 13, 17, and 18 rated as a high ecological risk (Figure 5.2).

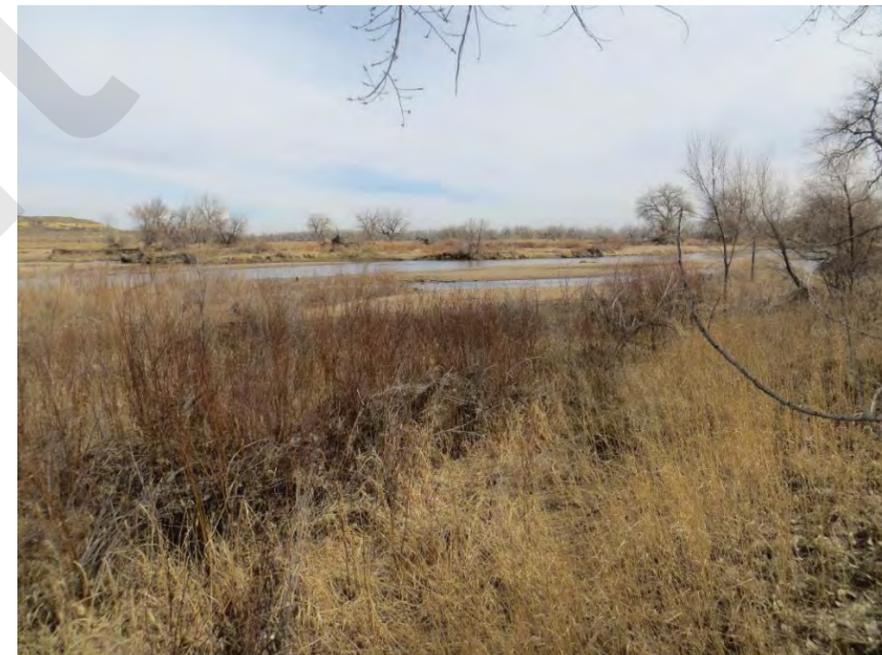
Photo 1.1 - Bottom of Reach 1, looking across from south to north, *S. Exigua* in the foreground. Bare substrate with a *P. deltoids* overstory on the north bank.

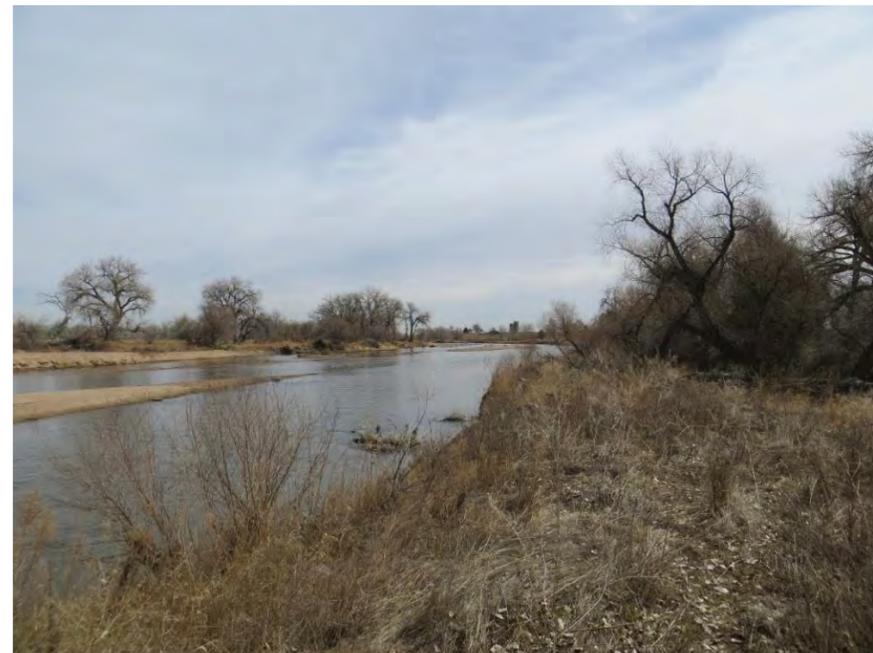
Photo 2.1 – Top of reach 2 south Bank looking downstream, the south bank with a *P. deltoides* overstory with mostly declining individuals, herbaceous understory

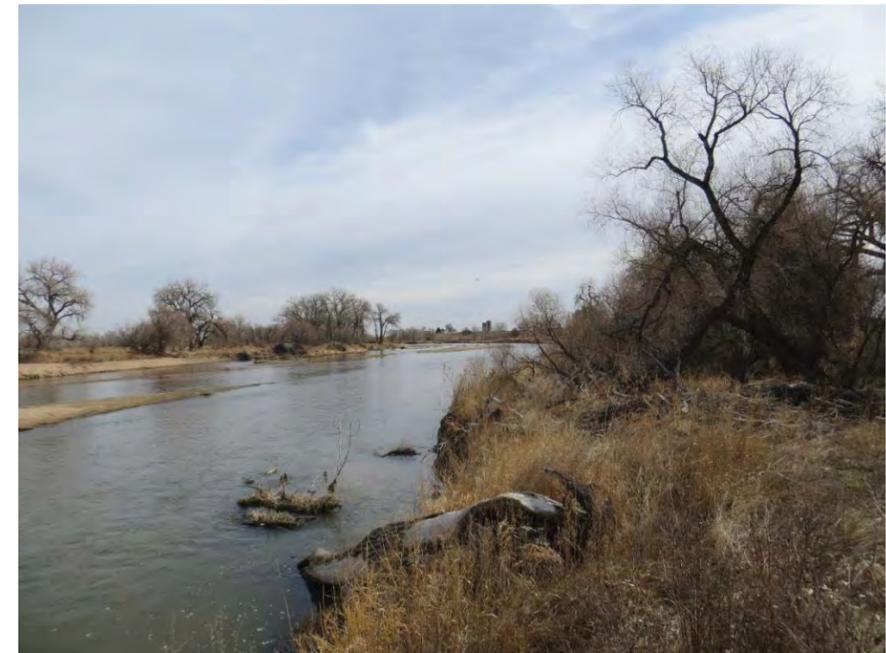
Photo 2.3 – Top of Reach 2 looking downstream, south bank with some woody debris, but with steep and failing banks

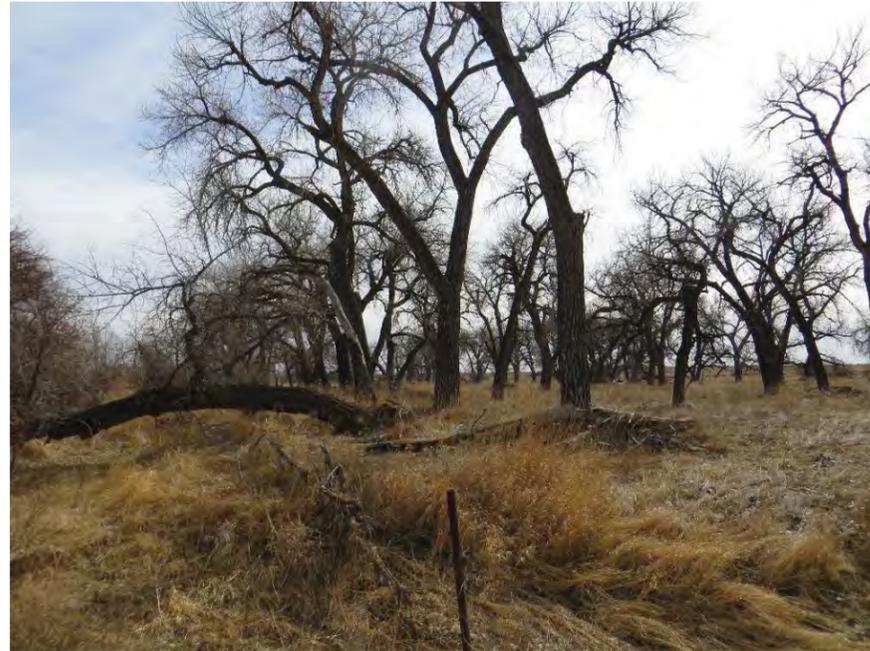
Photo 2.4 – Top of Reach 2, south bank, intact riparian corridor with a *P. deltoides* overstory and an intact *Bromus* grass understory from remnant agricultural applications which creates good cover.

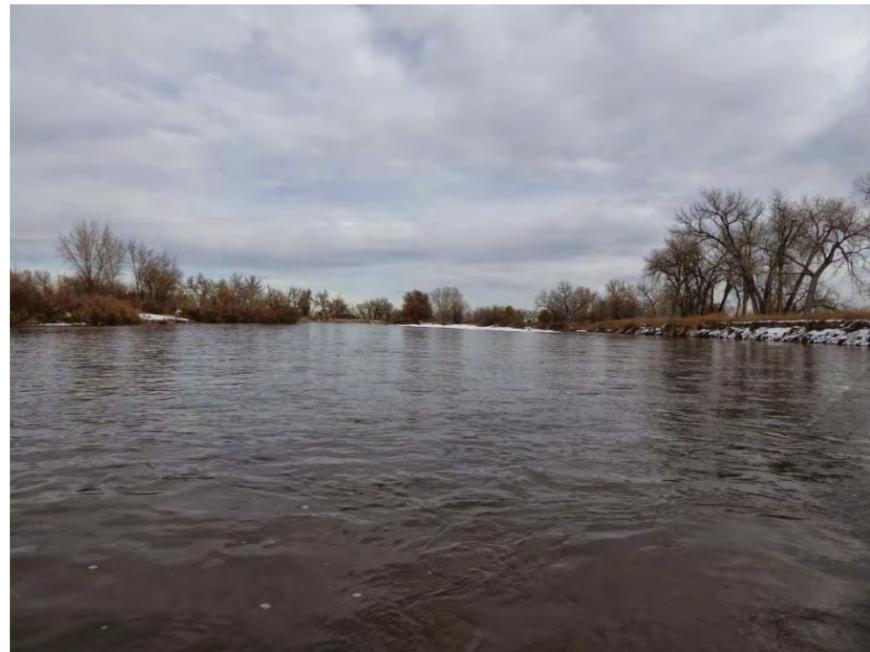
Photo 3.1 – Mid-Reach 3, looking downstream, steep and cut banks on the south bank, with a higher shrub component, *Salix*, on the north bank

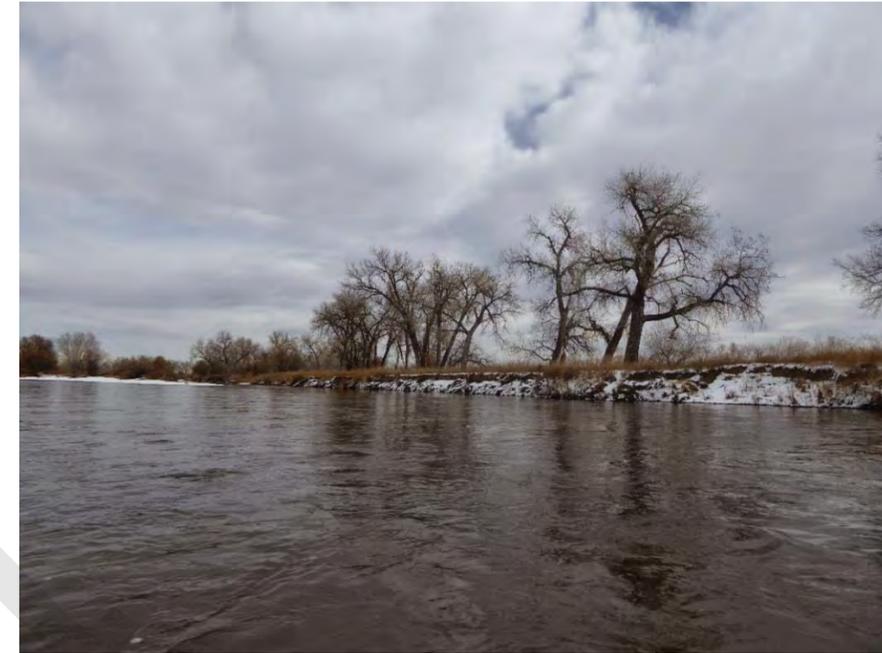
Photo 3.2 – Mid-Reach 3, looking toward the south bank, steep failing banks visible with a *P. deltoides* overstory and herbaceous understory with a higher shrub component further downstream.

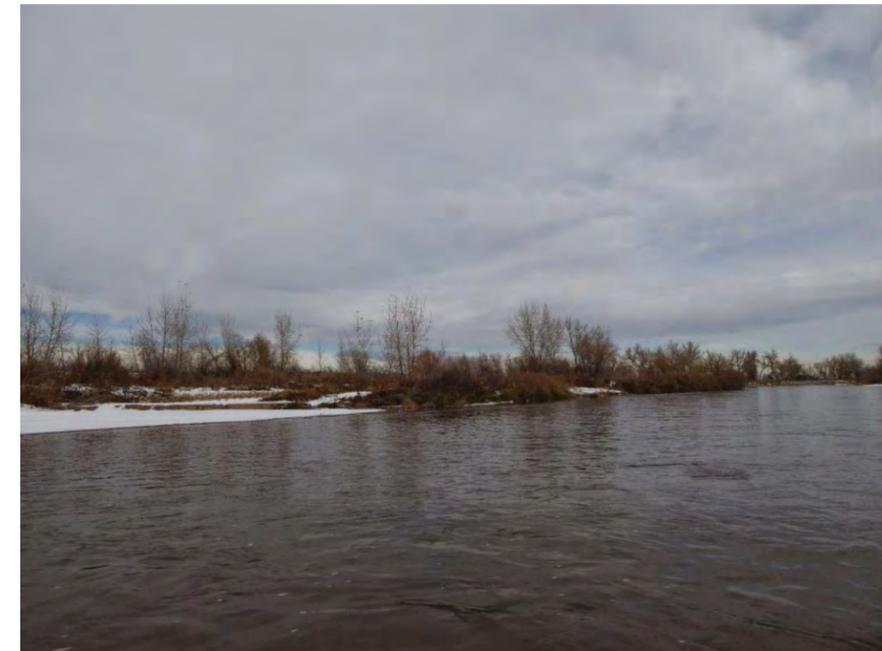
Photo 3.3 – Mid Reach 3, looking toward the north bank, a large amount of bare ground, less steep banks and some regeneration of woody species present.

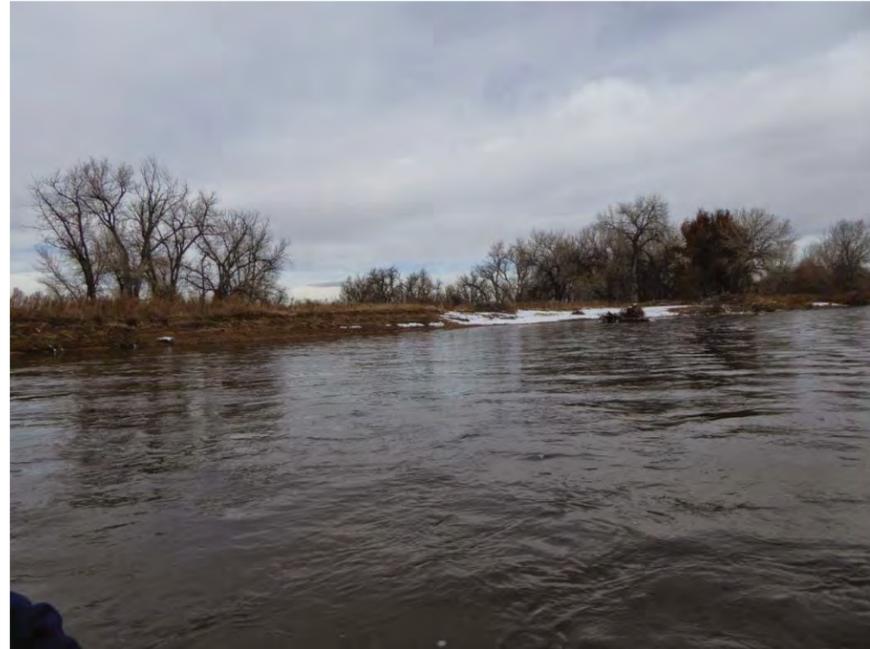
Photo 3.4 – Mid-Reach 3 looking toward the north bank. Steep, failing banks are visible with a more dense riparian forest downstream

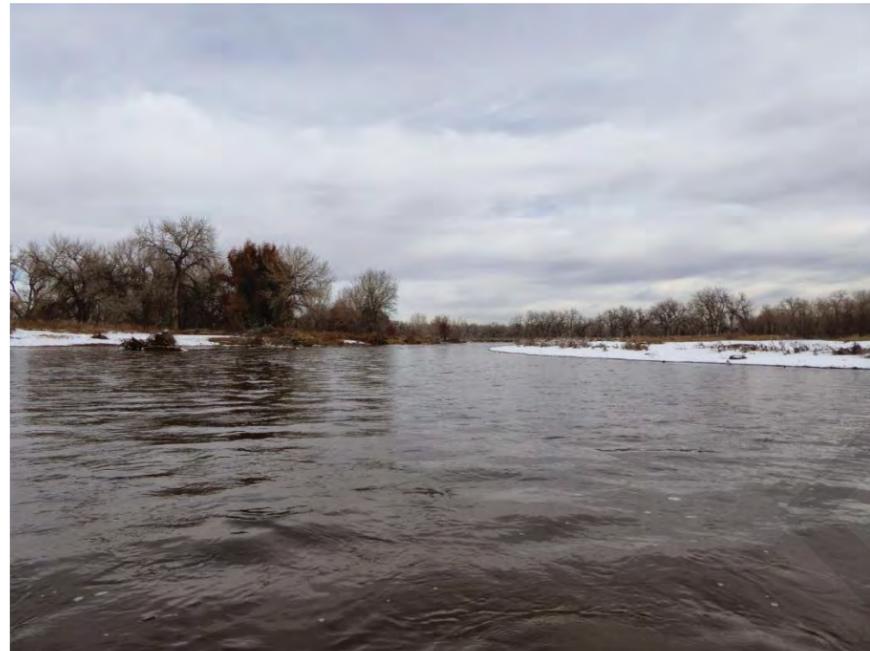
Photo 4.1 – Mid Reach 4, looking downstream, a point bar visible on the south bank and more dense riparian forest on the north bank

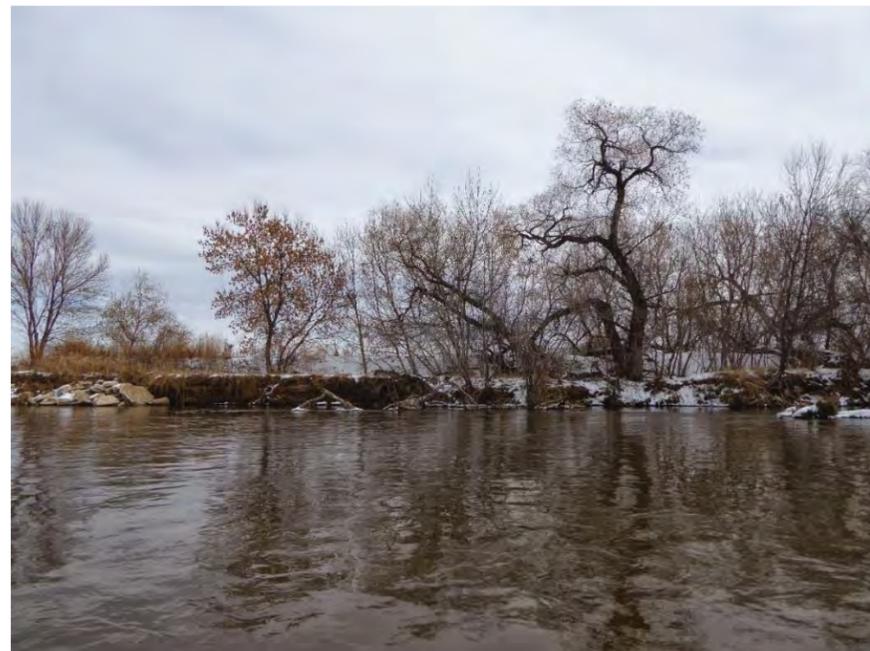
Photo 4.5 – Bottom of reach 4, looking toward the south bank, *P. deltoides* overstory, with portions of the bank armored with concrete rubble and other portions bare and failing. Some regeneration is present in this reach.

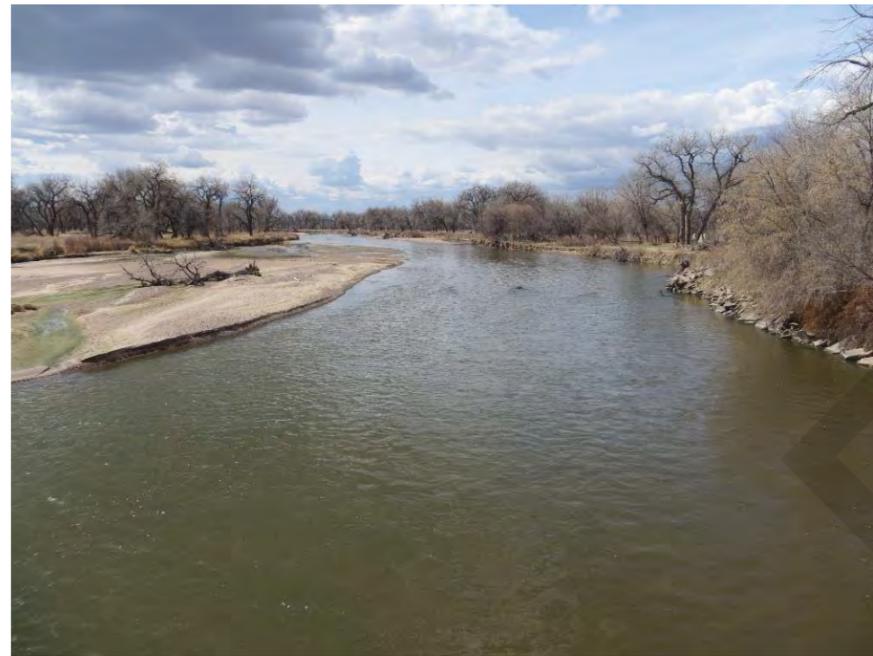
Photo 5.1 – Bottom of Reach 5, from the Highway 60 Bridge looking upstream. Deposition of sediment on the south bank from bridge infrastructure. Wide and dense riparian along both banks.

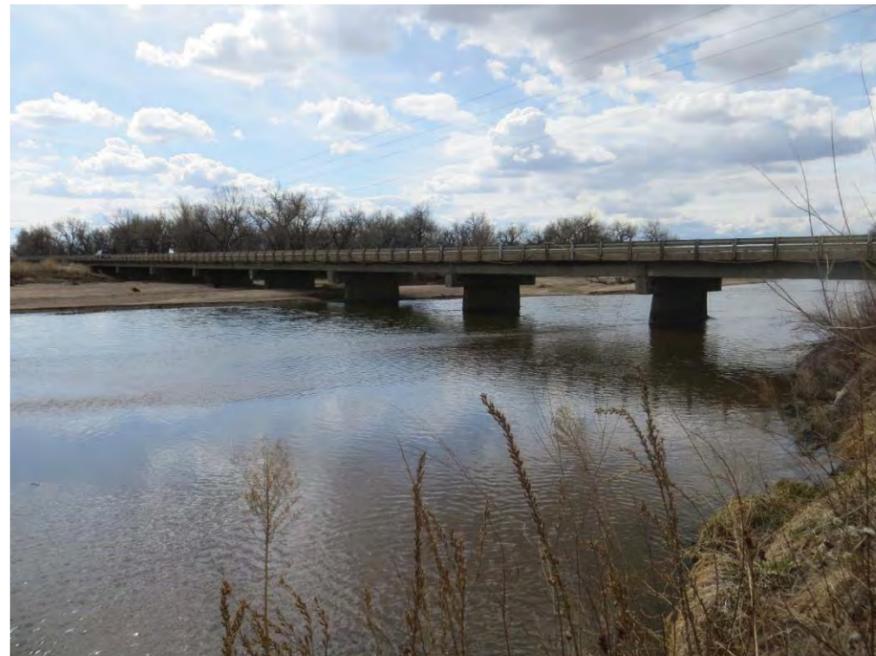
Photo 6.1 – Top of Reach 6, looking upstream towards Highway 60 Bridge, sediment deposition along the south bank and mid channel created by bridge infrastructure.

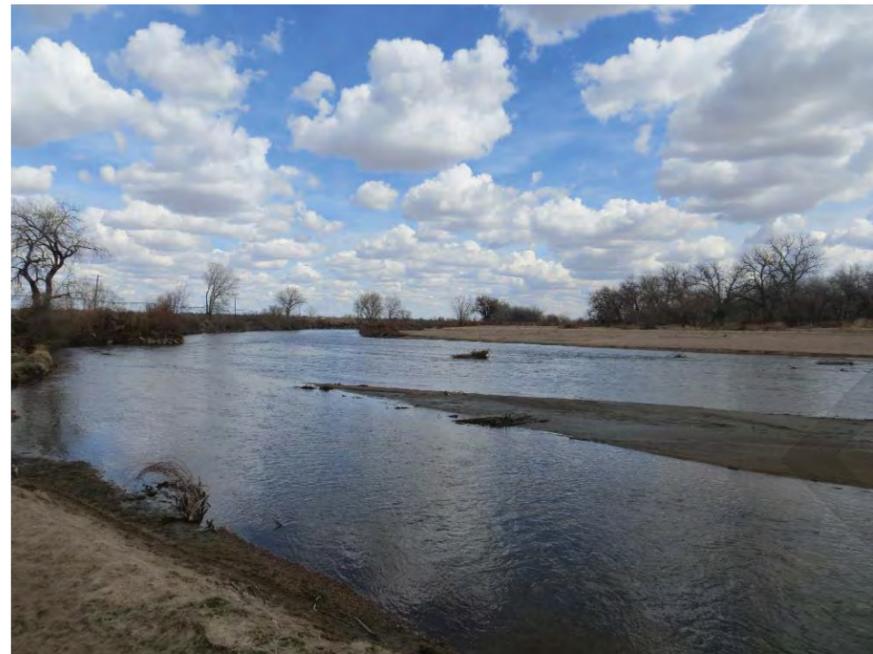
Photo 7.1 – Top of Reach 7, looking downstream from the north bank, bare substrate and deposition of sediment below the diversion structure located at the top of the reach. Very thin riparian areas line this reach.

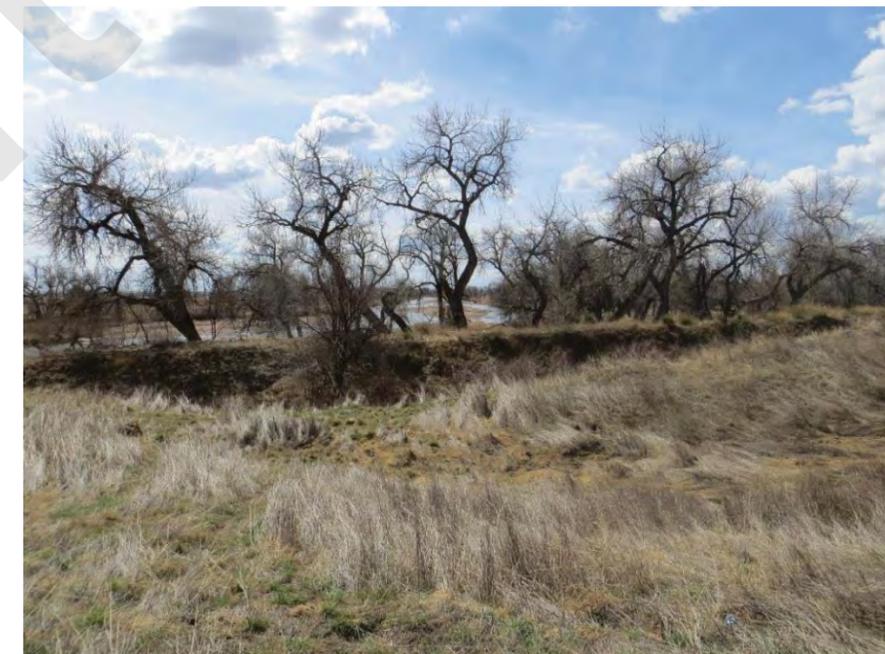
Photo 8.1 – Bottom of Reach 8, looking upstream from the north bank, the Big Thompson River channel is in the foreground and the riparian area between the South Platte River and the Big Thompson River is beyond. Confluence areas are important sites for restoration and benefit fish and wildlife species.

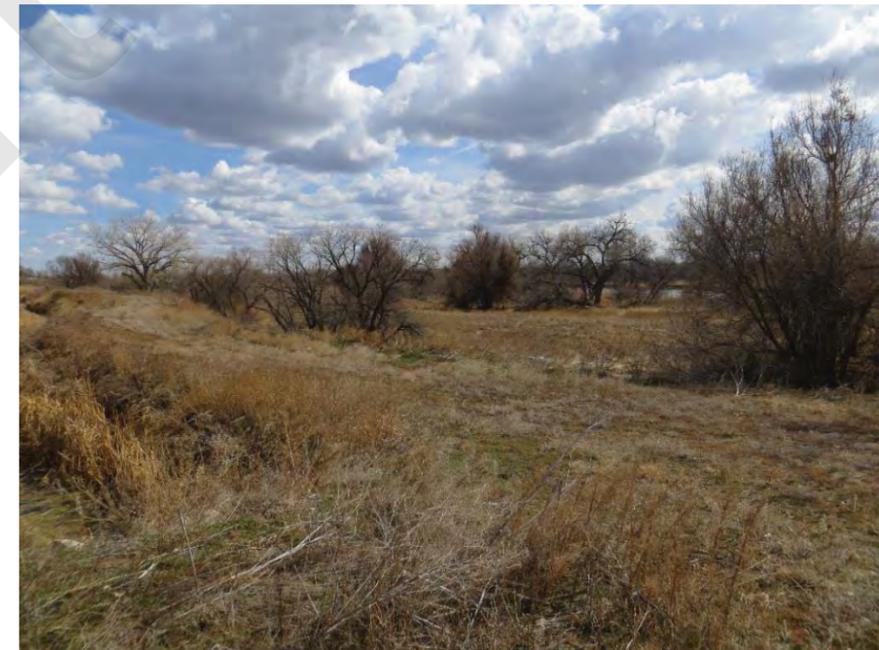
Photo 9.1 – Mid-Reach 9, north bank looking towards river channel from edge of riparian, patches of P. deltooides are visible, a very tall tree in the background provides excellent avian habitat.

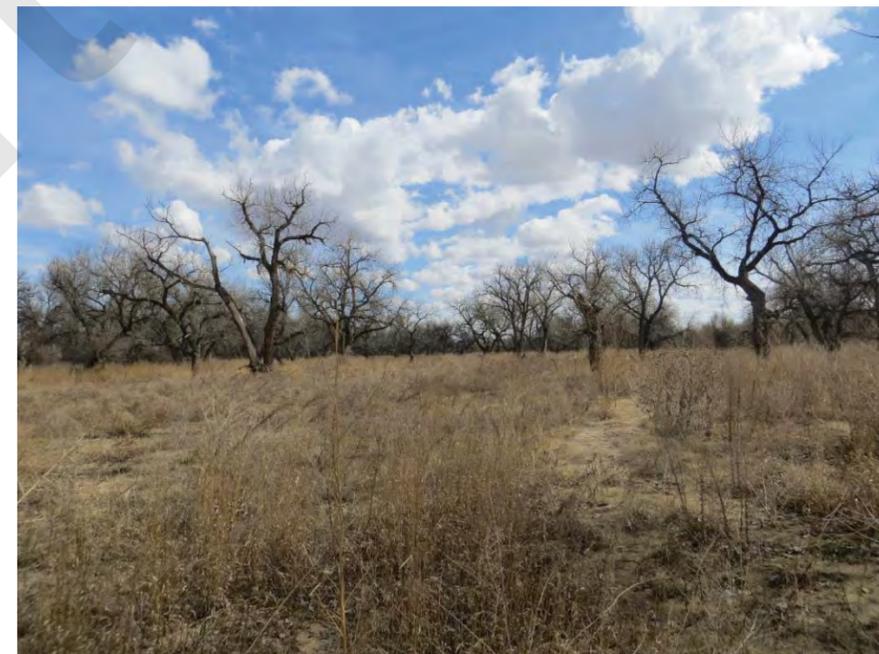
Photo 10. 1 – Mid-Reach 10, Riparian forest on the north bank. The riparian area is wide with a *P. deltooides* overstory and a *graminoid* and other native grass understory.

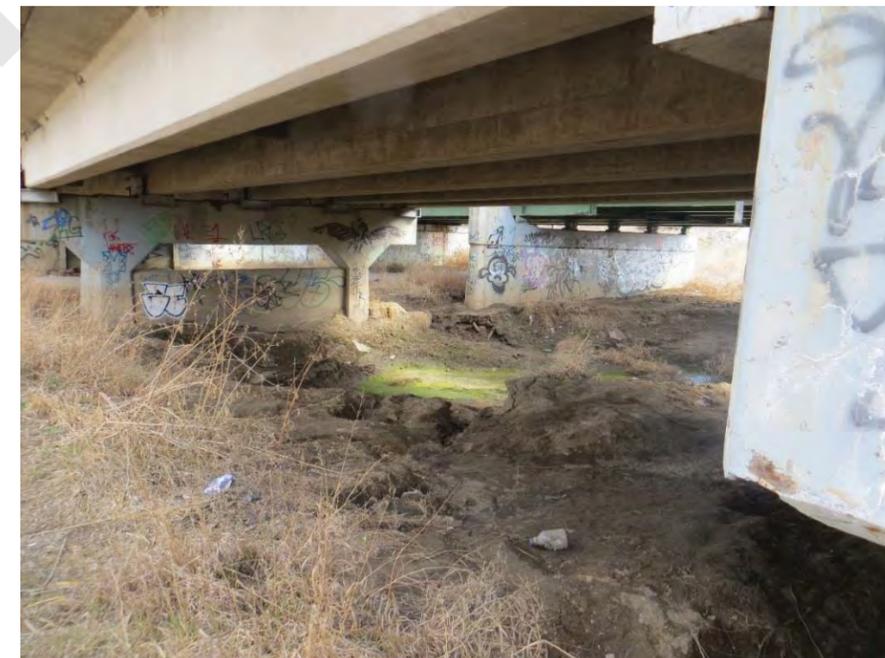
Photo 11.1 – Bottom of Reach 11, north bank under Highway 85 Bridge, high concentrations of algal growth are present which is an indicator of nutrient enrichment and degraded water quality.

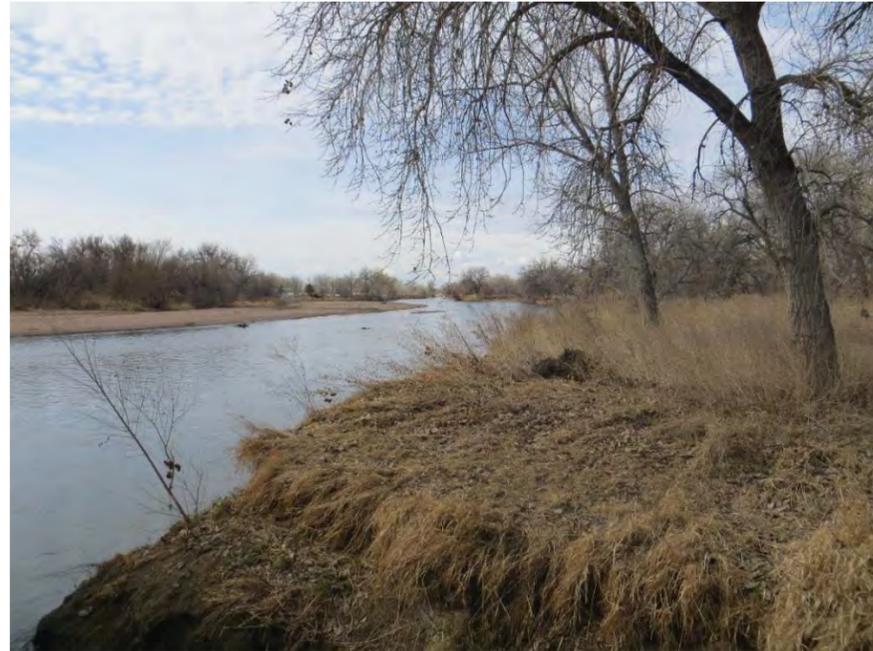
Photo 11.2 – Bottom of Reach 11, looking upstream from the north bank. The north bank riparian corridor is fairly wide with patchy *P. deltoides* and *U. parvifolia* overstory. The south bank has a thin riparian corridor with residential areas interspersed within.

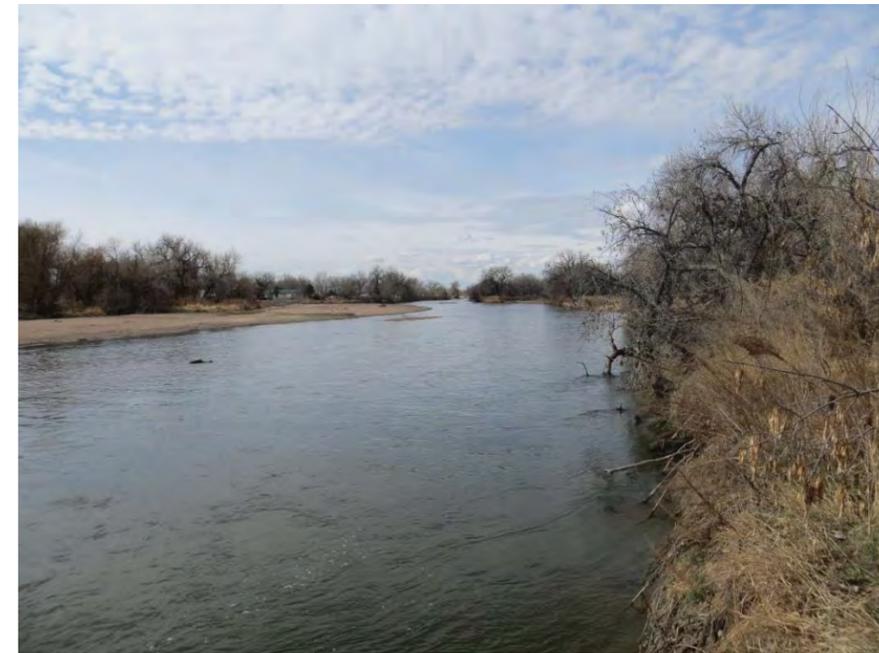
Photo 11.5 – Bottom of Reach 11, looking up stream. Steep and failing banks are present along the north bank and a point bar is present on the southern bank.

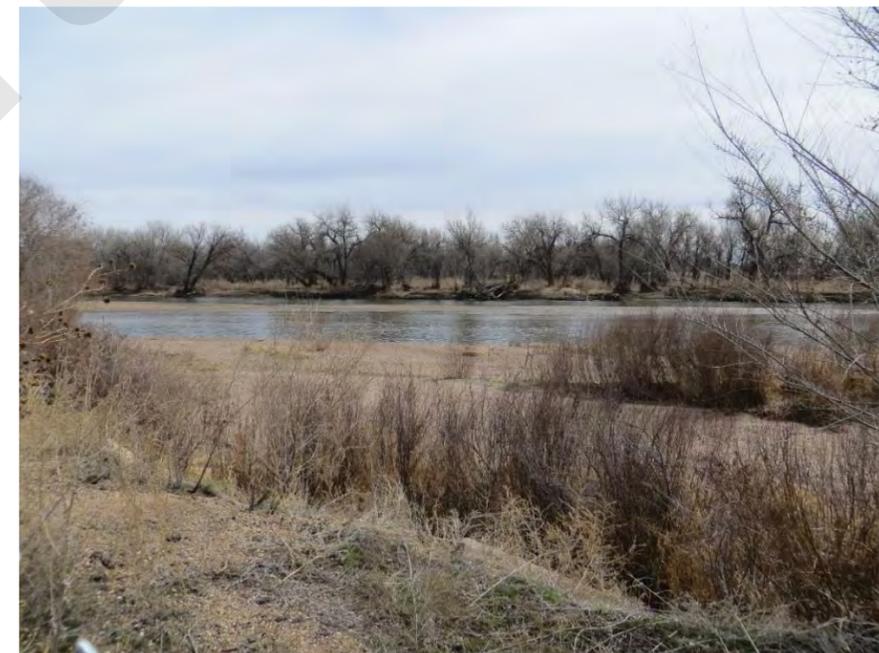
Photo 12.1 – Mid-Reach 12, Riverside Park, looking from the north bank to the south bank. The *Salix*, shrub component in the foreground is located on a point bar along the north bank. The south bank contains a riparian forest with a *P. deltoides* overstory and herbaceous understory.

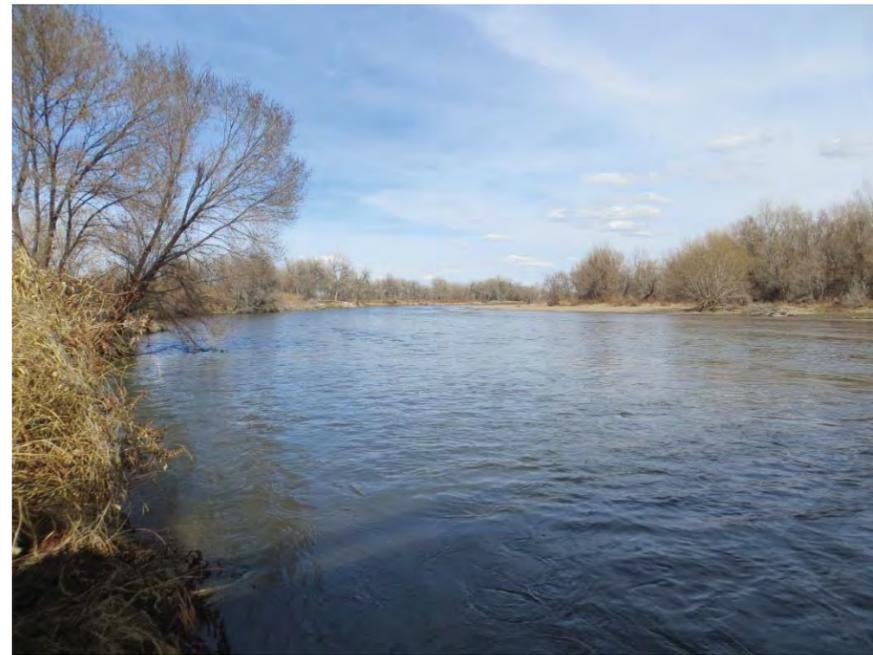
Photo 13.1 – Top of Reach 13 looking down stream. The north bank and south bank riparian corridors are thin towards the top of the reach but get wider further down in the reach.

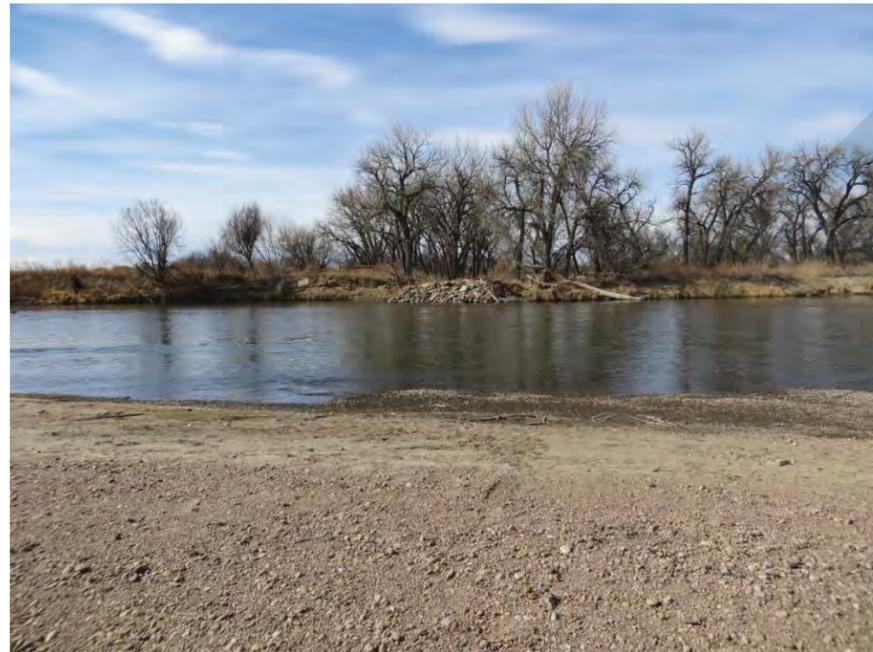
Photo 13.5 – Near the top of Reach 13, looking from the south bank to the north bank. Steep and degraded banks are visible with some armoring along the north bank.

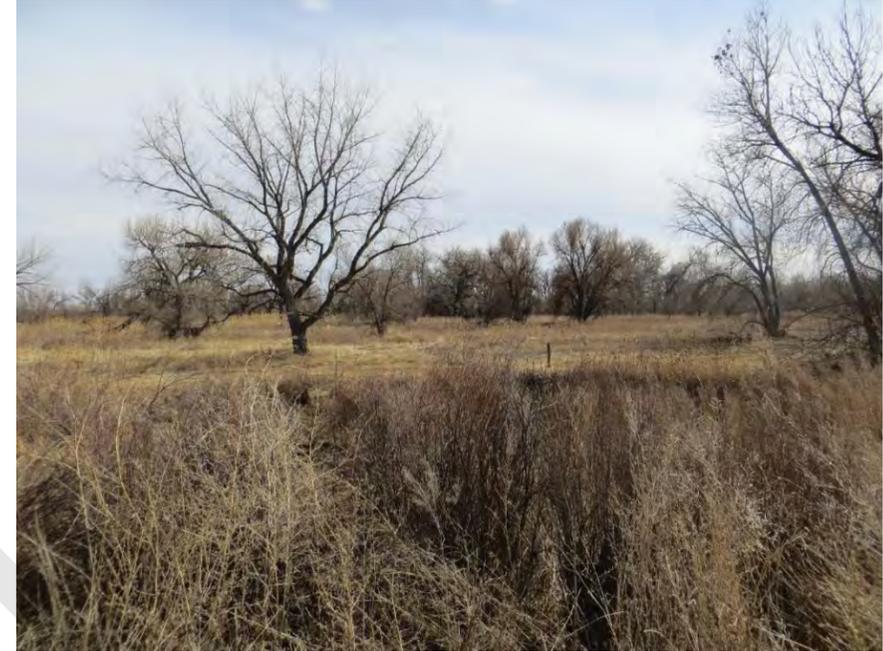
Photo 13.6 – Near the top of Reach 13, looking from the south bank out into the riparian corridor. The riparian is very thin with no regeneration of the *P. deltoides* overstory.

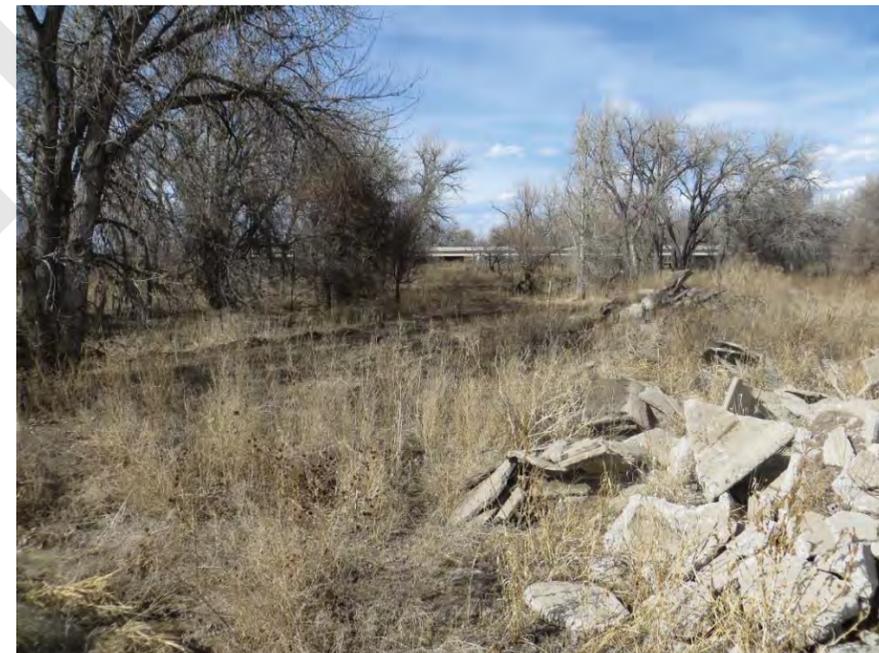
Photo 14.1 – Near the bottom of Reach 14 on the south bank, looking downstream. Rip-rap from a historic channel was present in this reach towards the outside of the thin riparian corridor. Possibly a good location for restoration of off channel wetlands.

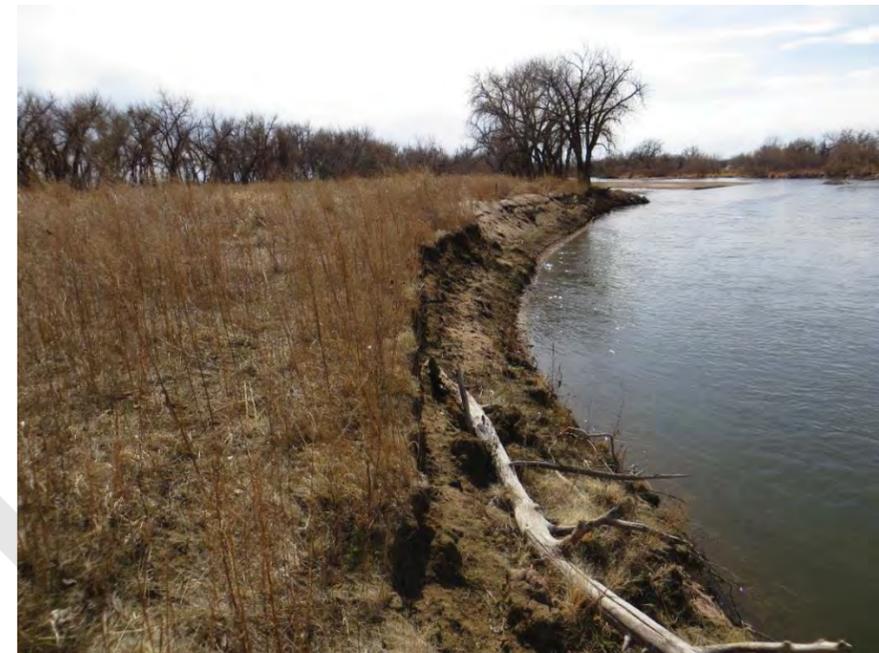
Photo 14.4 - Near the bottom of Reach 14 on the south bank, looking upstream. Steep and failing banks are present as well as disconnect from the floodplain.

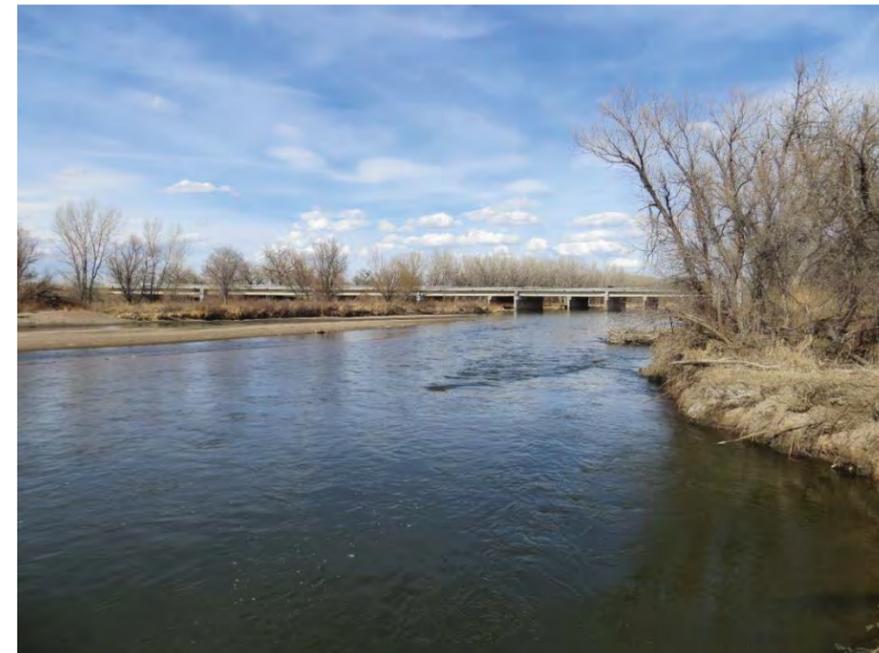
Photo 14.5 - Bottom of Reach 14 on the south bank, looking downstream. View of Highway 34 Bridge with sediment deposit above the bridge in the middle of the channel.

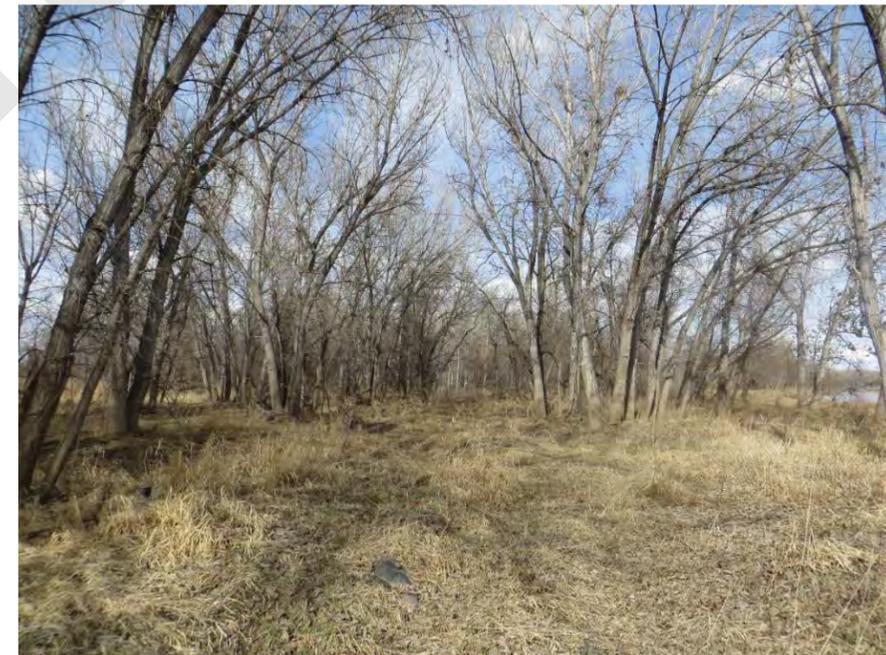
Photo 15.1 – Top of Reach 15, looking downstream. Visible in this photo is a good example of the excellent age class diversity of the dominant overstory.

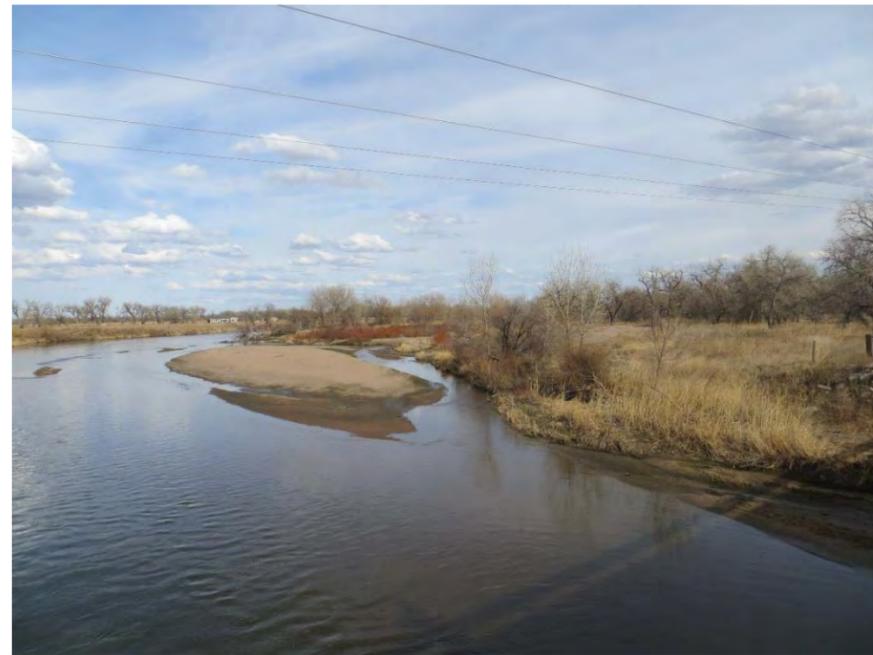
Photo 16.1 – Top of Reach 16 looking downstream. A depositional island is present below the Highway 34 Business Loop Bridge.

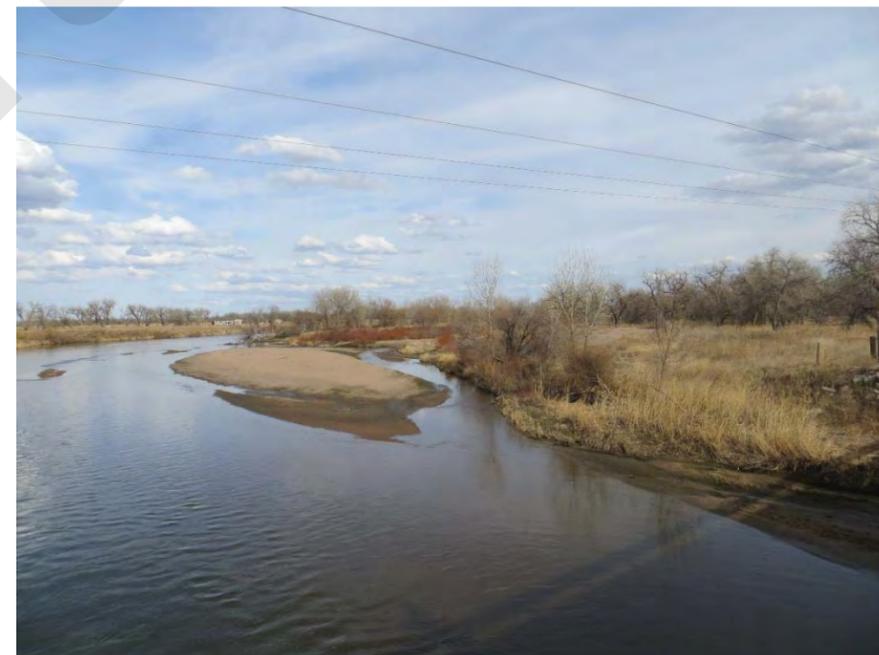
Photo 16.1 – Top of Reach 16 looking downstream. A depositional island is present below the Highway 34 Business Loop Bridge.

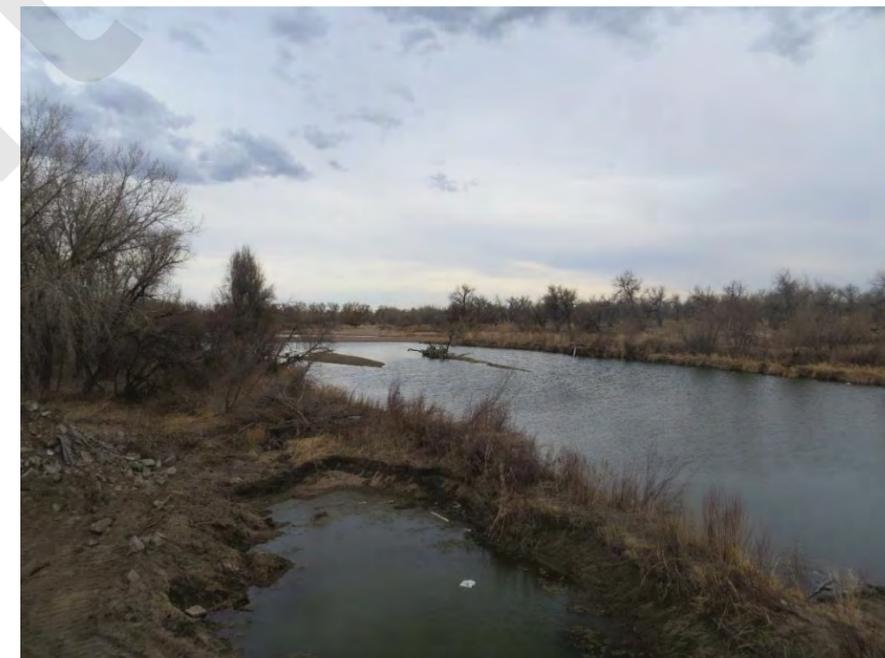
Photo 17.1 – Bottom of Reach 17, looking upstream along the south bank. This reach is adjacent to high intensity agriculture and evidence of nutrient enrichment is present. This reach also has a fair amount of bare ground present.
