South Platte River Restoration Master Plan

Prepared for:
City of Evans, Colorado

Prepared by:
CDM Smith

Appendix A

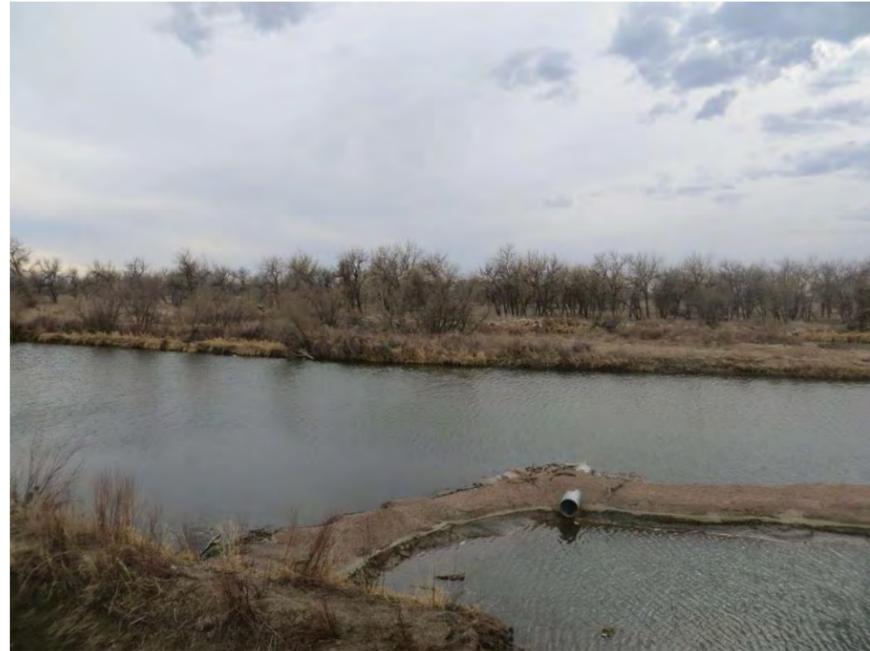
Photo 17.2 – Bottom of Reach 17, looking from the south bank to north bank. The diversion in the foreground is for construction of the new 18th Street Bridge. The riparian along the north bank is visible and is fairly degraded.

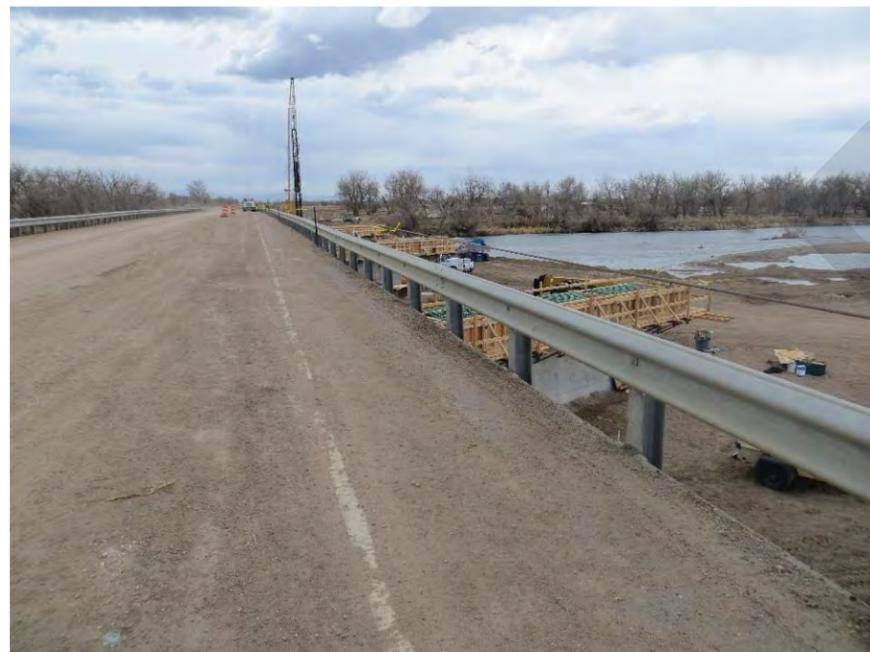
Photo 17.3 – Bottom of Reach 17, looking across the new 18th Street Bridge from the south bank to the north bank.

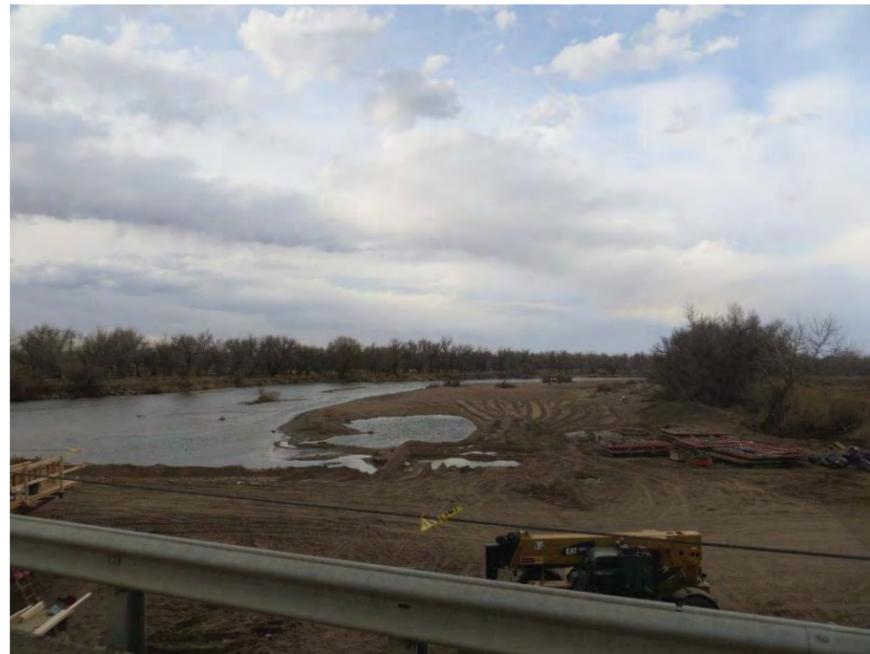
Photo 18.1- Top of Reach 18, looking downstream along the south bank. The south bank is mostly bare, due to construction of the new bridge, however the riparian is very thin on the south bank and directly adjacent to agricultural activities. The north bank is somewhat wider however livestock are grazing within the riparian corridor.

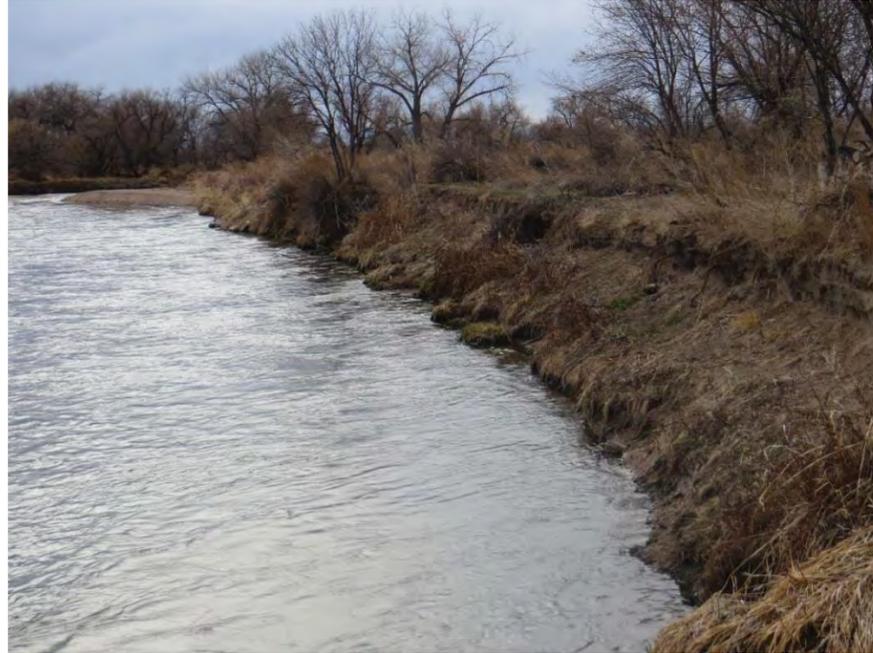
Photo 18.4 - Bottom of Reach 18, looking upstream from the north bank. Steep and failing banks are present at the bottom of the reach, further upstream banks are armored.

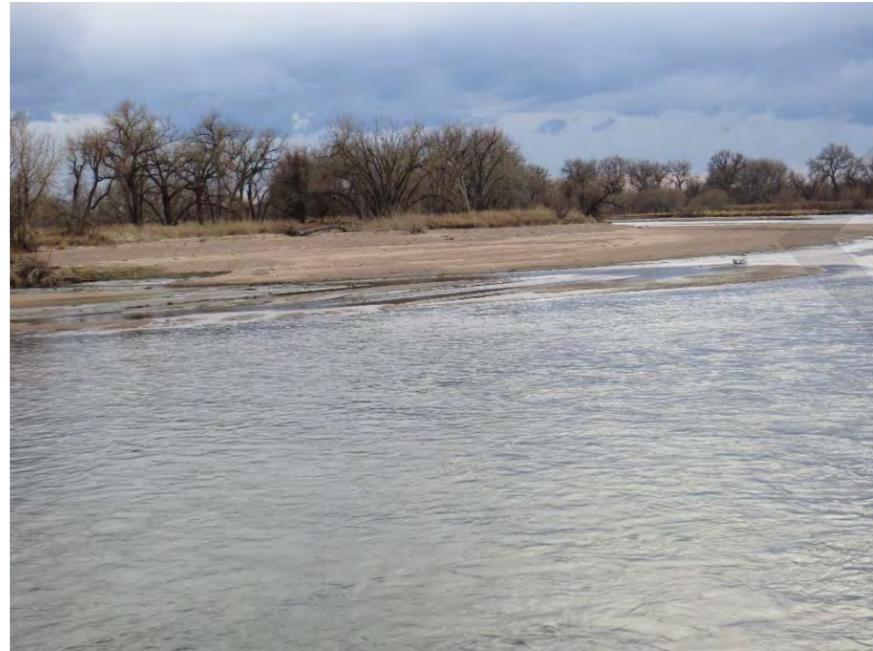
Photo 18.5 – Bottom of Reach 18, looking across from the north bank to the south bank. A large point bar is visible. The riparian is in better condition at the bottom of the reach than the top.

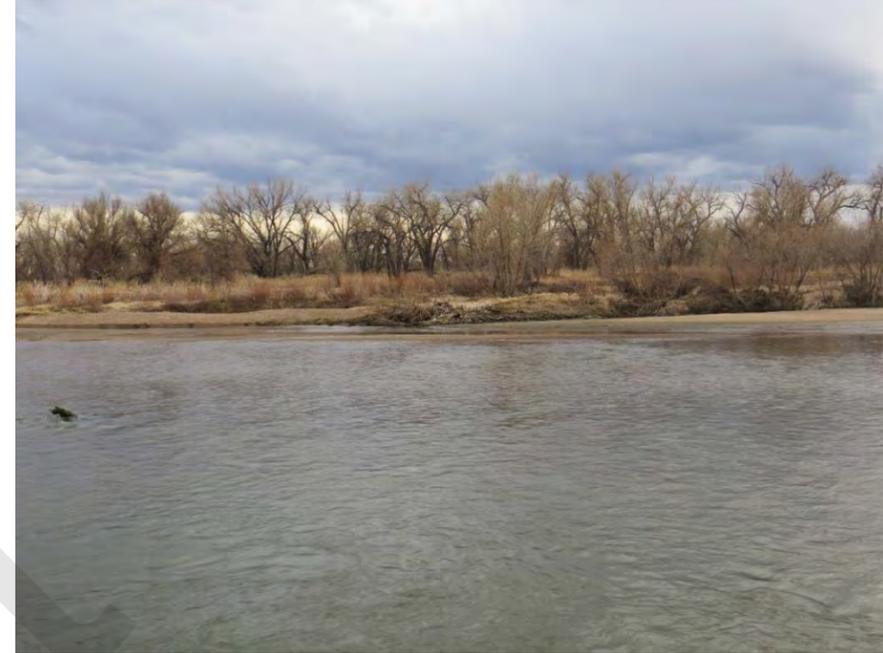
Photo 18.6 – Bottom of Reach 18, looking across from the north bank to the south bank. The area between the two rivers is an important area for ecological preservation and restoration. This will benefit both aquatic and terrestrial wildlife.
