South Platte River Restoration Master Plan

Prepared for:
City of Evans, Colorado

Prepared by:
CDM Smith

Appendix A

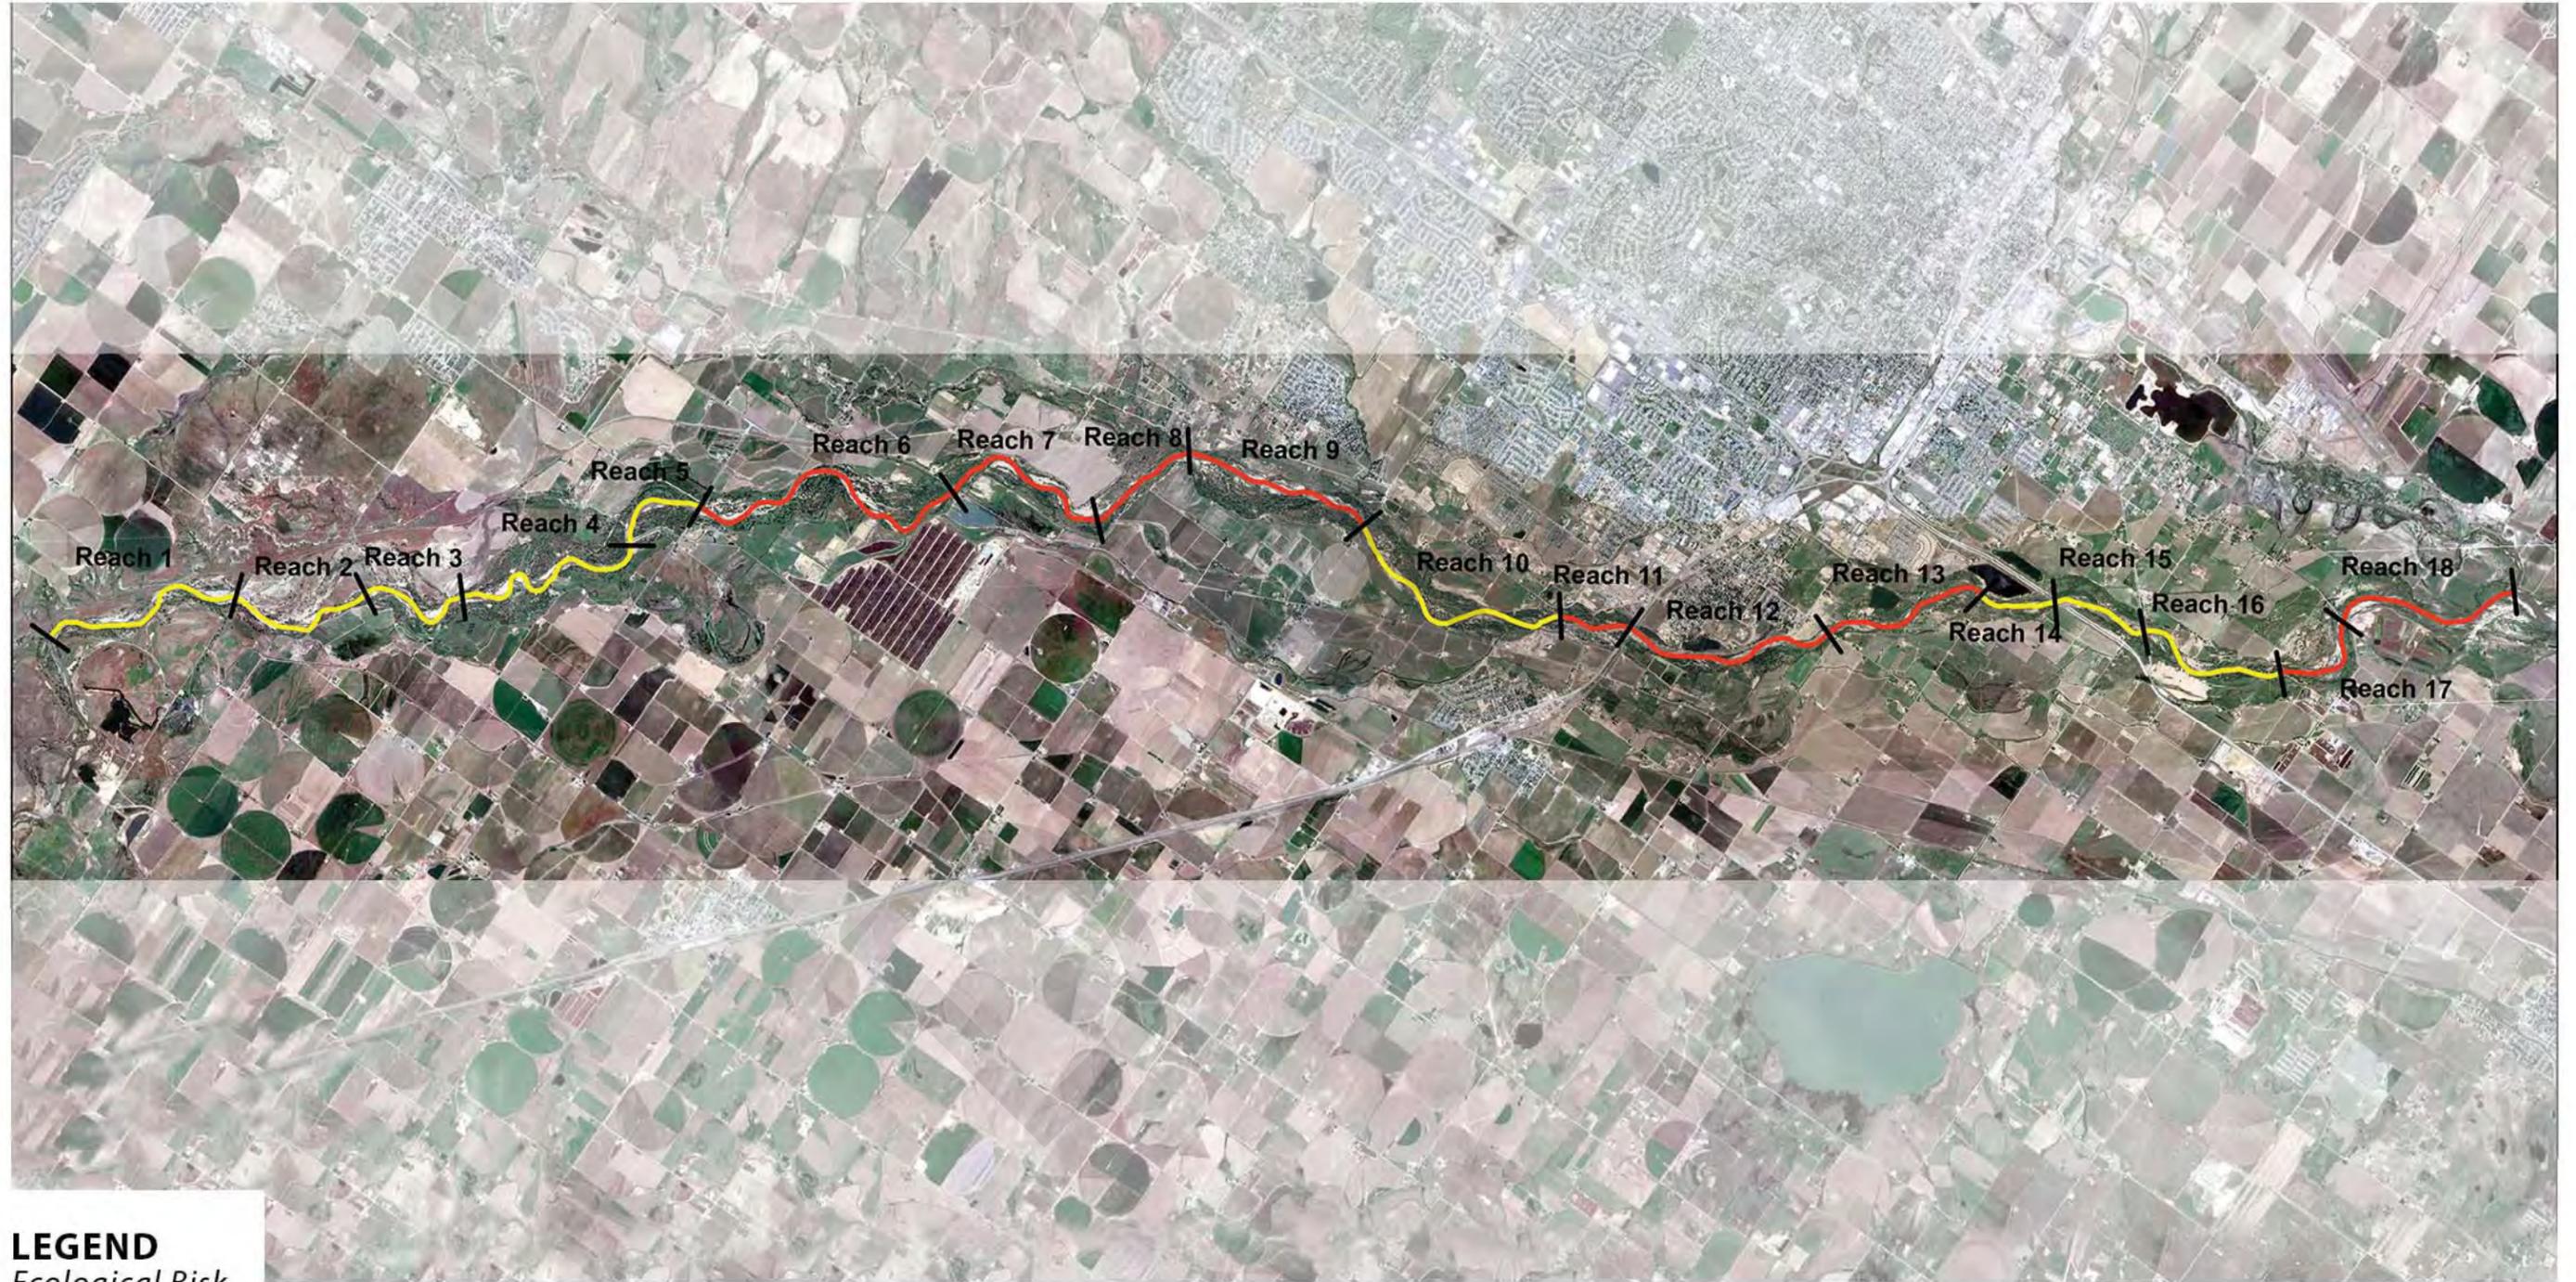
Figure 5.2

The majority of the 18 reaches were rated as severely degraded and poor, with exception of Reach 15 which rated fair (Figure 5.1). Overall, the South Platte River channel is highly modified with large portions of the river bank failing. Steep banks are falling into the stream and widening, which creates point bars and deposition within the active channel. There are very few locations where there is connection to the floodplain. On average, the riparian area is fairly wide; however, there are large gaps in the vegetation along the stream bank, which decreases the riparian quality rating. The overall riparian quality through the study area also rated low due to the lack of cottonwood and willow species regeneration. Additionally, there were significant concentrations of invasive plant species present. Water quality within the study area is negatively impacted by land use practices adjacent to the river. Surface runoff from agriculture and industrial sources promote excessive algal and plant growth. Habitat for aquatic species lack diversity within the study area, and the presence of irrigation diversion structures also impact the movement of aquatic species. Reaches 1, 2, 4, 5, 10, 14, 15, and 16 rated as a medium ecological risk, while reaches 3, 6, 7, 8, 9, 11, 12, 13, 17, and 18 rated as a high ecological risk (Figure 5.2).

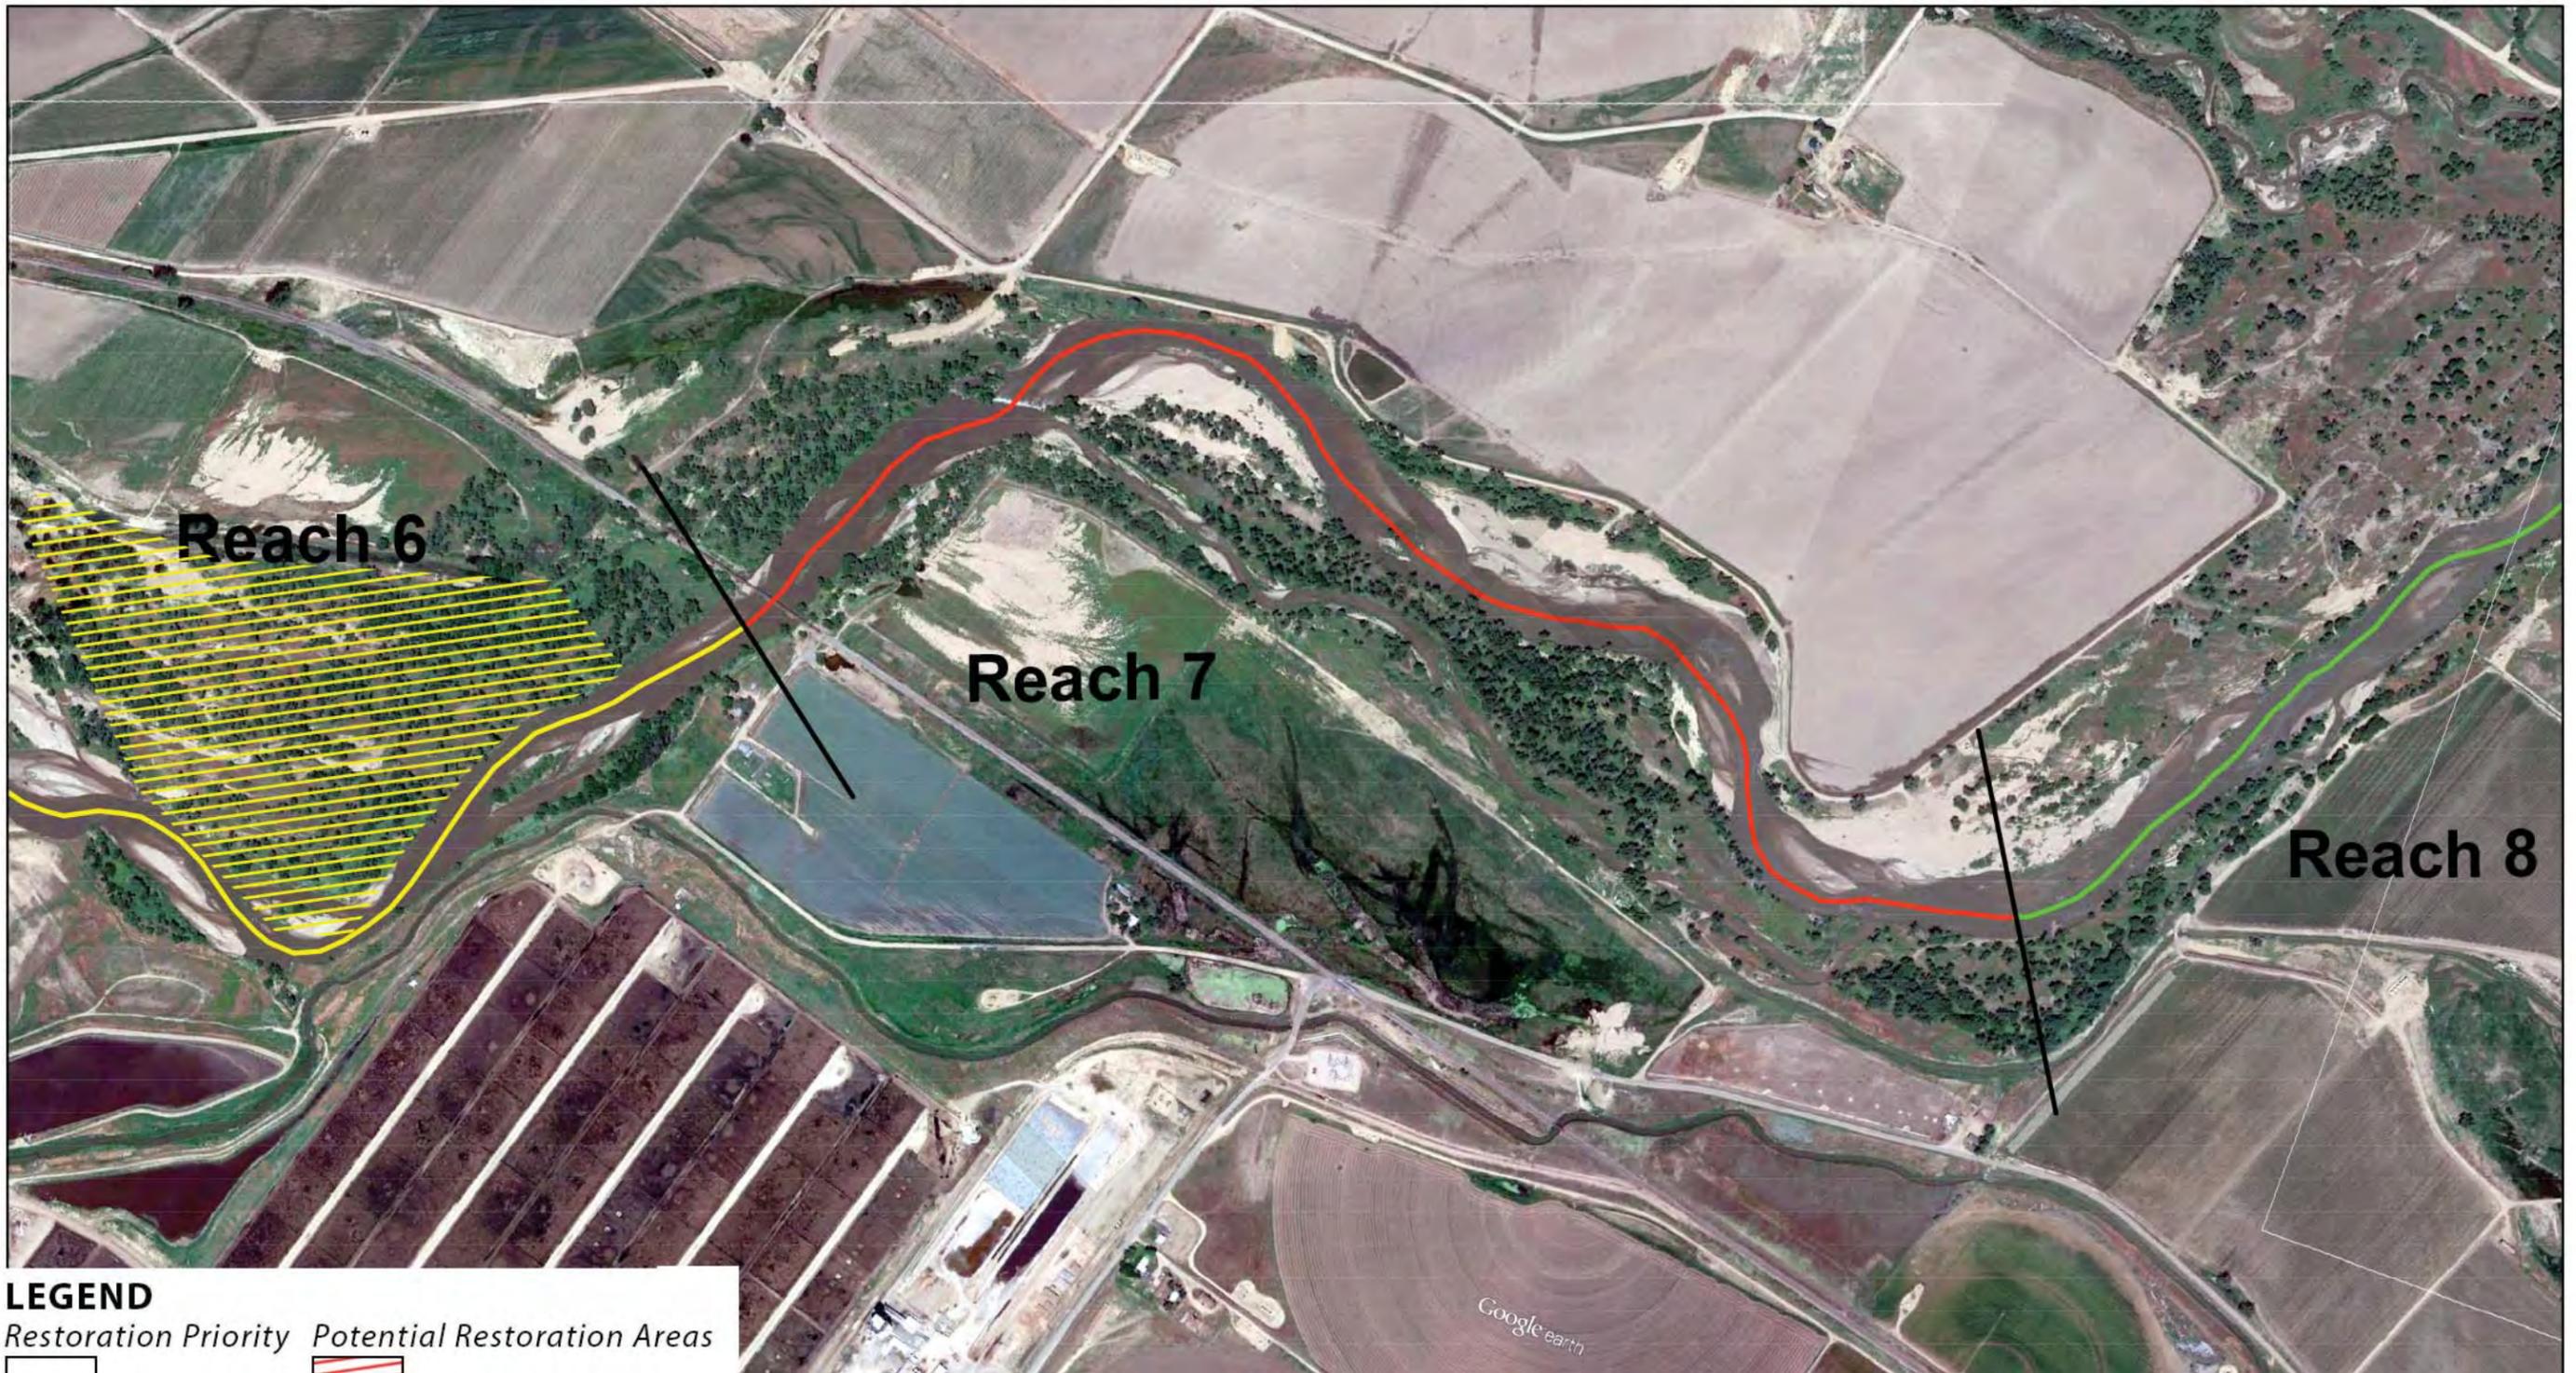
Figure 6.2.4

8	The bottom of Reach 8 is the confluence with the Big Thompson River and provides another high priority for preservation of current ecological condition. This would be a good location for restoration of riparian and wetland conditions that would benefit aquatic and terrestrial wildlife species (Figure 6.2.4 and Figure 6.2.5).	High
9	This portion of the river is highly incised with collapsing and failing banks adding sediment to the bedload. Riparian benching along these vertical banks would, promote redevelopment of riparian vegetation on the north bank and reduce sediment input along the southern bank, where the majority of the reach has vertical failing banks. The degree of degradation along this reach make it a low priority ecologically.	Low
10	This reach has high potential for restoration of in-channel and riparian corridor functions due to the presence of off-channel ephemeral wetlands, and back-channel stream threads. This reach is also adjacent to Weber State Wildlife Area, which may facilitate making improvements to this reach (Figure 6.2.5 and Figure 6.2.6)	High

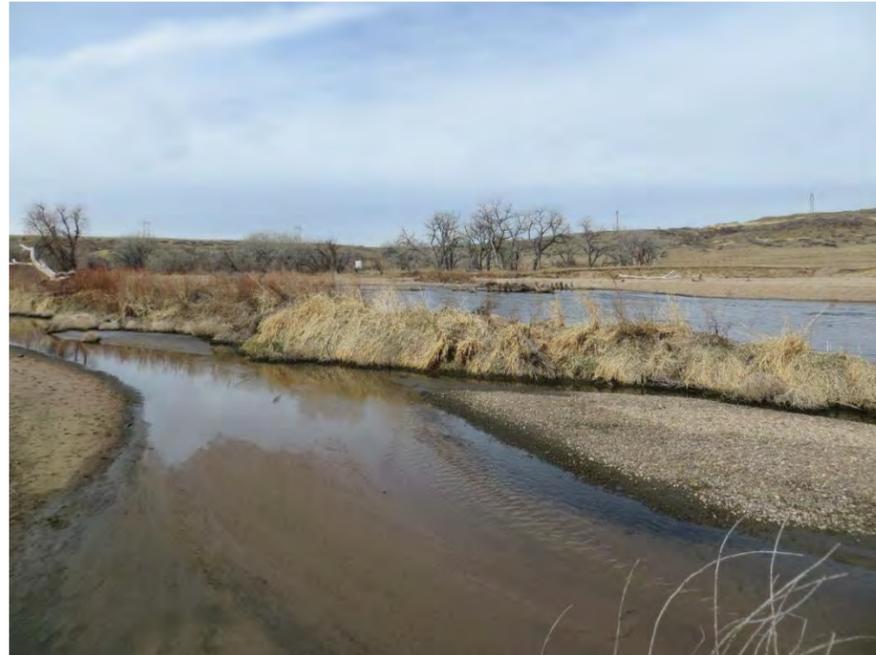
Photo 1.2 – Bottom of Reach 1, south bank looking upstream, side channel with herbaceous vegetation covering the gravel bar. On the north bank, more bare substrate and *P. deltoides* overstory is present.

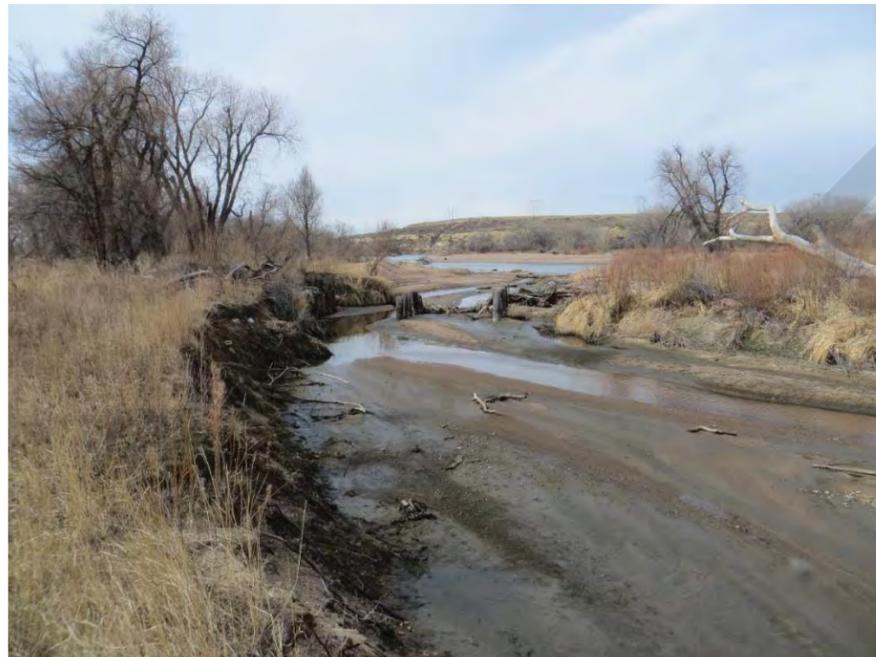
Photo 1.3 – Bottom of Reach 1, south bank looking upstream, top of side channel along south bank, a good example of aquatic habitat diversity.

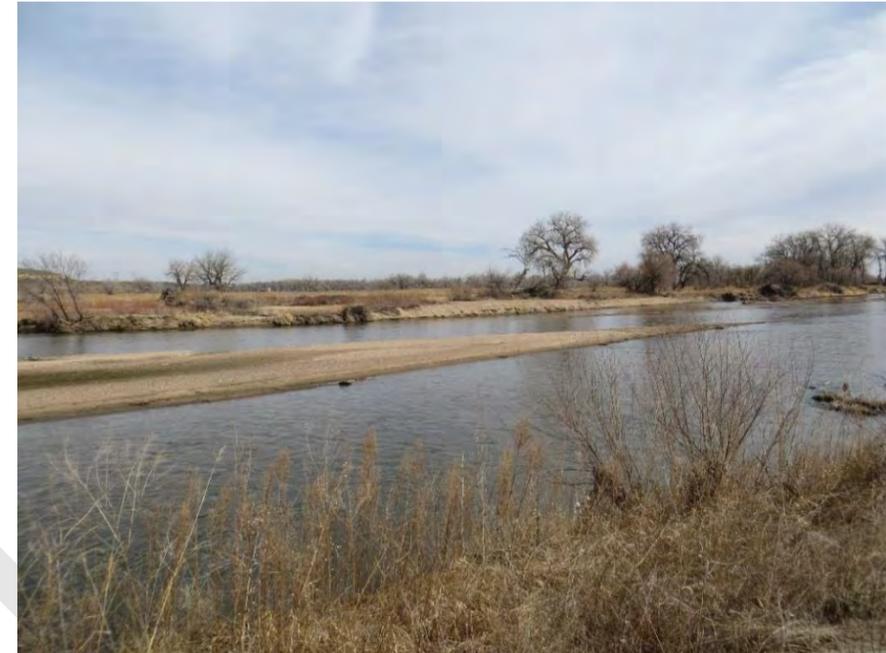
Photo 2.2 – Top of Reach 2 looking across from south to north, depositional sand bar in foreground. The north bank with bare substrate and *P. deltoides* overstory.

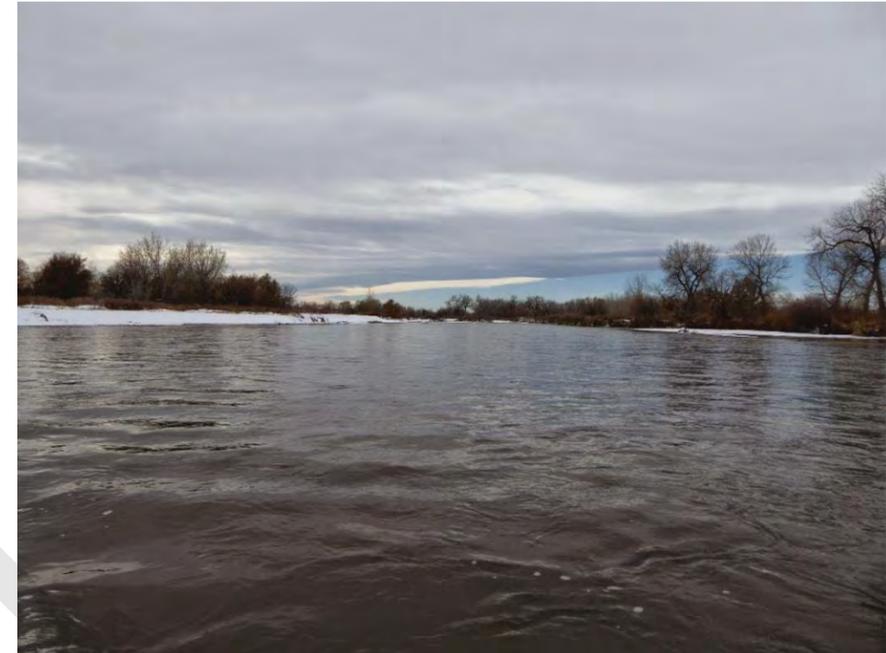
Photo 4.2 – Mid-Reach 4, looking downstream, bare substrate on the north bank with a higher percentage of shrub component, *Salix*, in the riparian along both the north and south banks and *P. deltoides* overstory

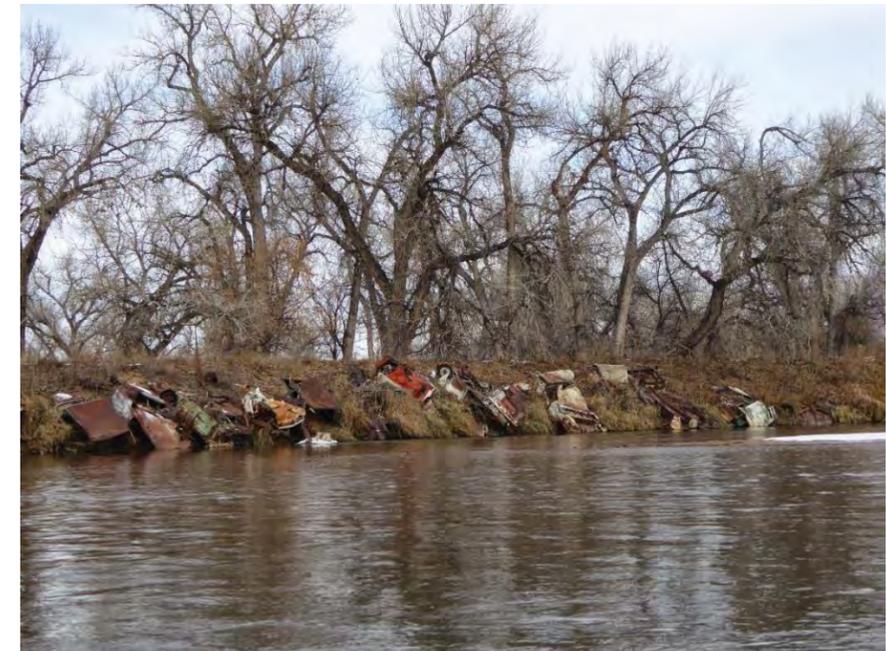
Photo 4.3 – Mid-Reach 4, looking toward the north bank, auto body bank cover with herbaceous cover in between cars. The bank is stable but very steep and the floodplain is disconnected

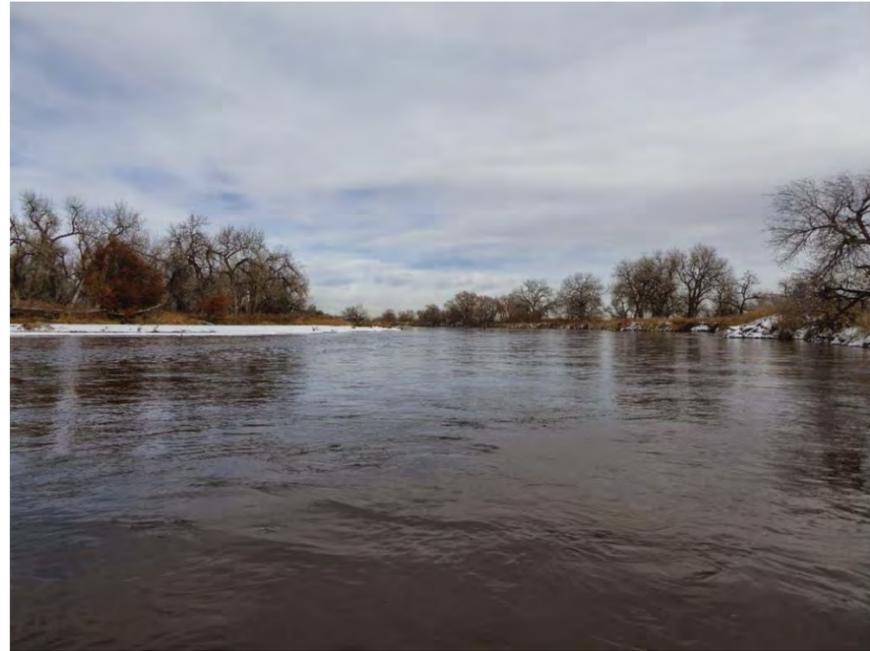
Photo 4.4- Mid Reach 4, looking downstream, a point bar is visible along the north bank, with steep banks along the south shore.

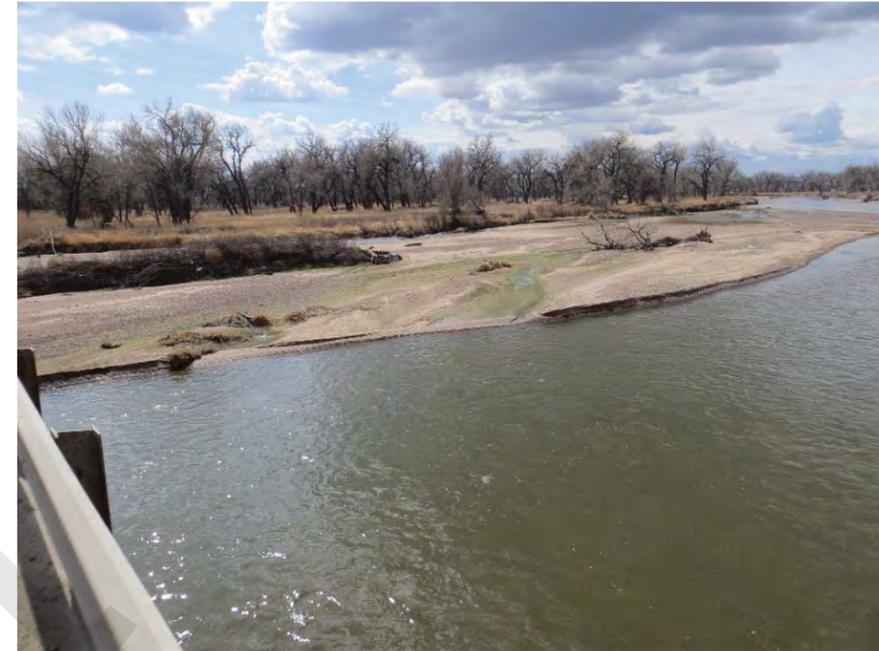
Photo 5.2 – Bottom of Reach 5, looking towards the south bank from the Highway 60 Bridge, depositional zone of mostly fine sediment, sand, and gravel above bridge.

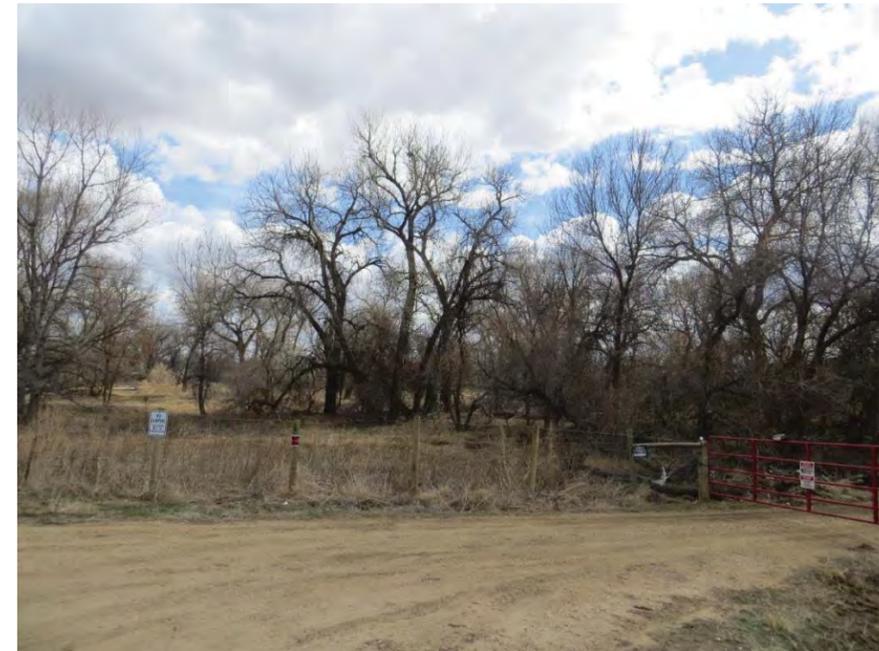
Photo 5.3 – Mid-Reach 5, north bank riparian area, with even aged and over mature *P. deltoides* making up the majority of the overstory with an understory of herbaceous vegetation.

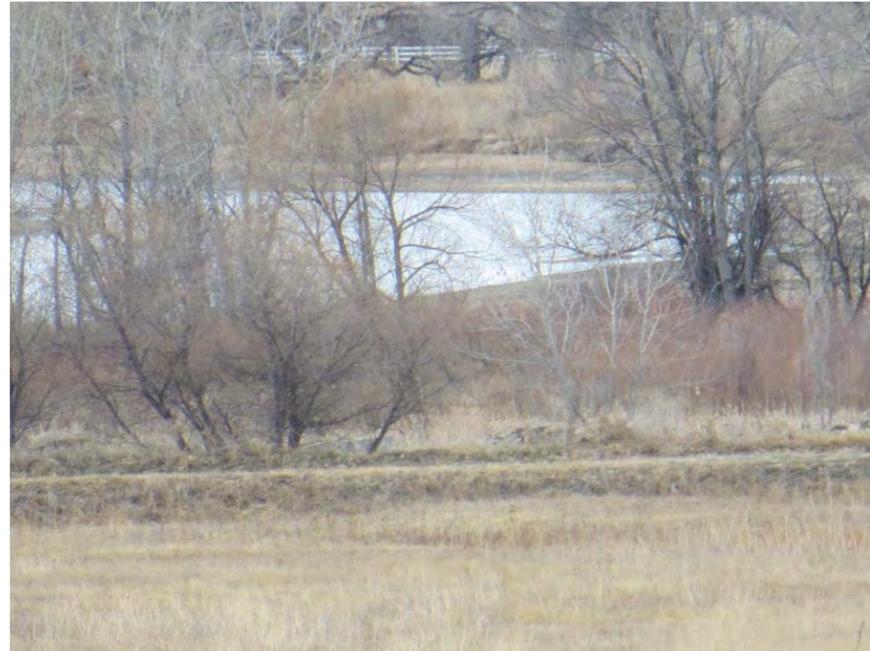
Photo 5.4 – Mid-Reach 5, looking from the south bank to the north bank, thin riparian area along the south bank, agricultural fields directly adjacent to riparian and stream channel.

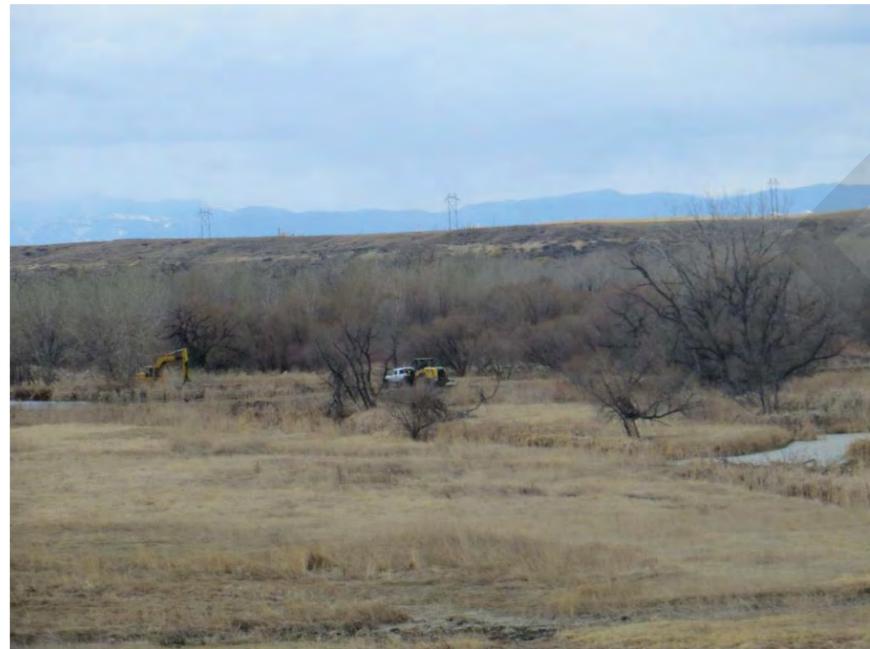
Photo 5.5 – Mid-Reach 5, looking from south of the riparian corridor to the northwest. Evidence of industry within the floodplain. Irrigation canal in the foreground with a dense riparian in the background.

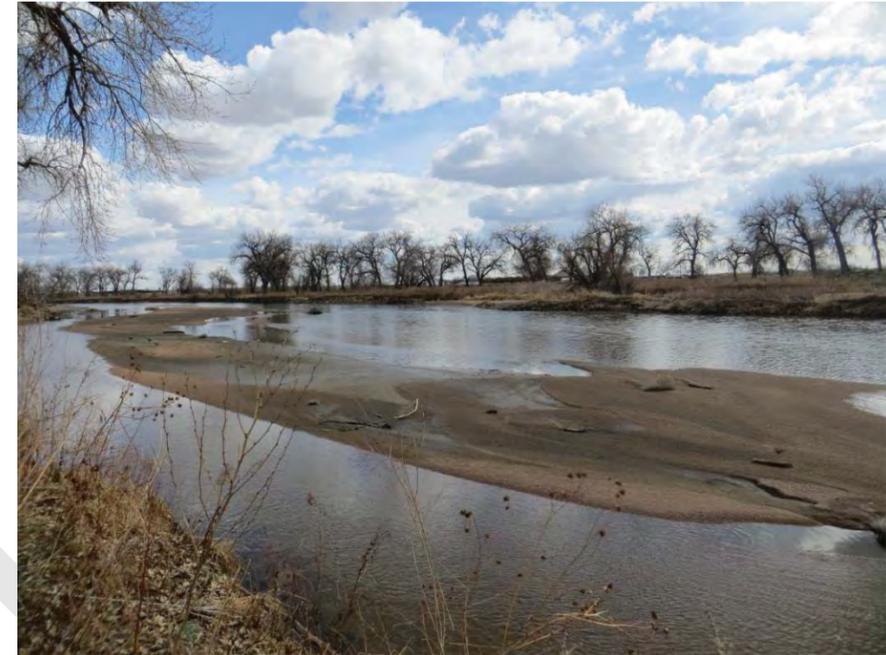
Photo 6.2 – Close to the top of Reach 6, looking from the north bank to south bank, large sediment depositional zone created by the Highway 60 bridge infrastructure. Thin riparian corridor along the south bank.

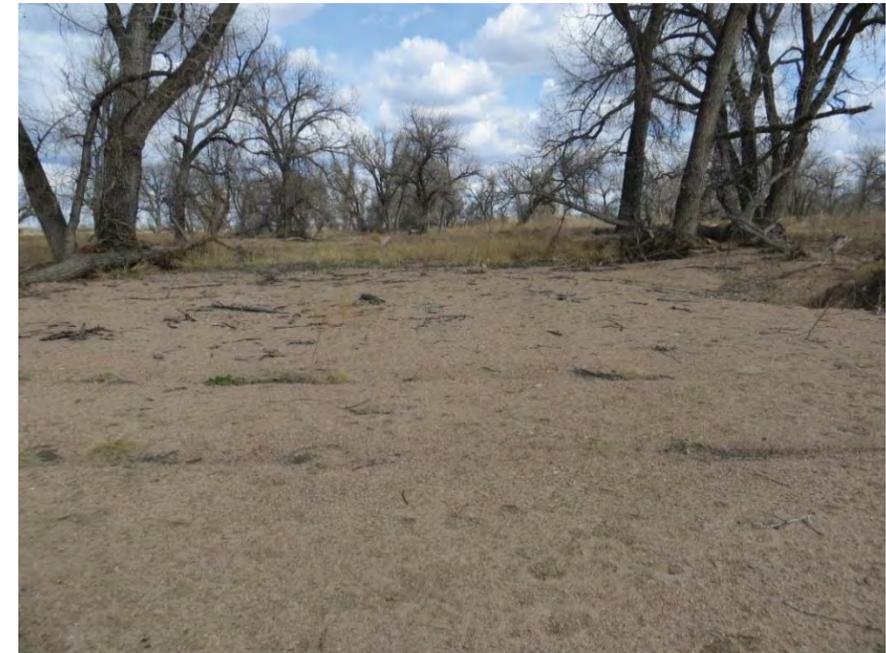
Photo 6.3 – Close to the top of reach 6, riparian area along north bank, slightly wider with a large proportion of bare ground visible. Mature overstory of *P. deltoides* with little to no regeneration, the floodplain is completely disconnected.

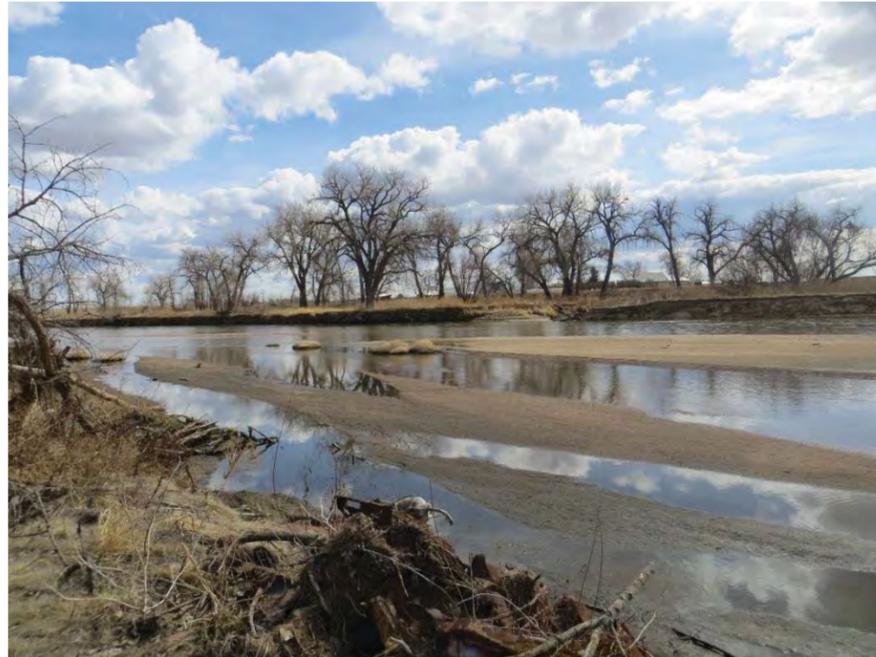
Photo 6.4 – Close to top of Reach 6, looking toward the south bank, steep banks with a thin riparian corridor along the south bank. Some woody debris and habitat diversity for aquatic species along the north bank.

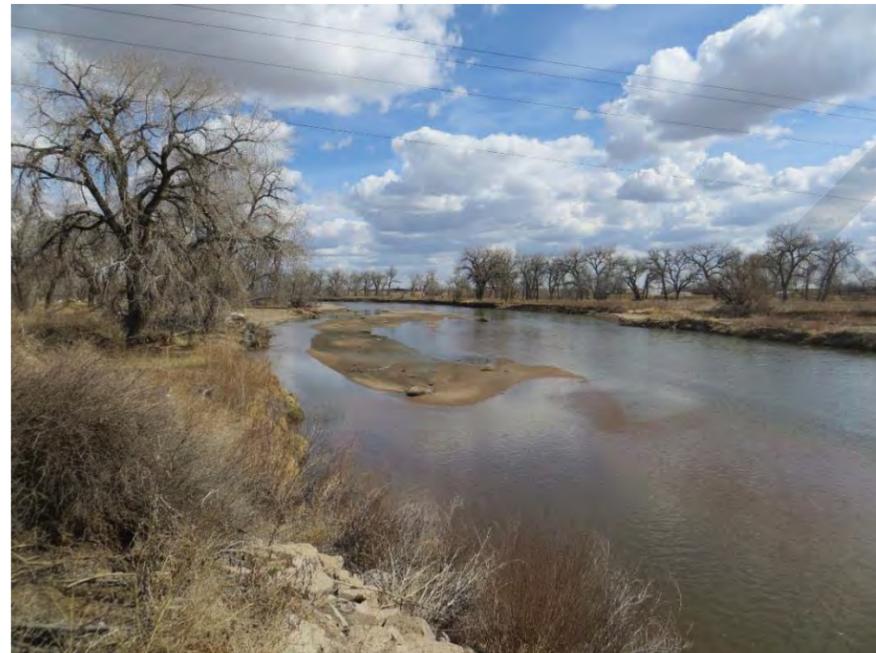
Photo 6.5 – Top of Reach 6, looking downstream, lack of connectivity to floodplain is visible with steep banks separating the channel from the riparian corridor.

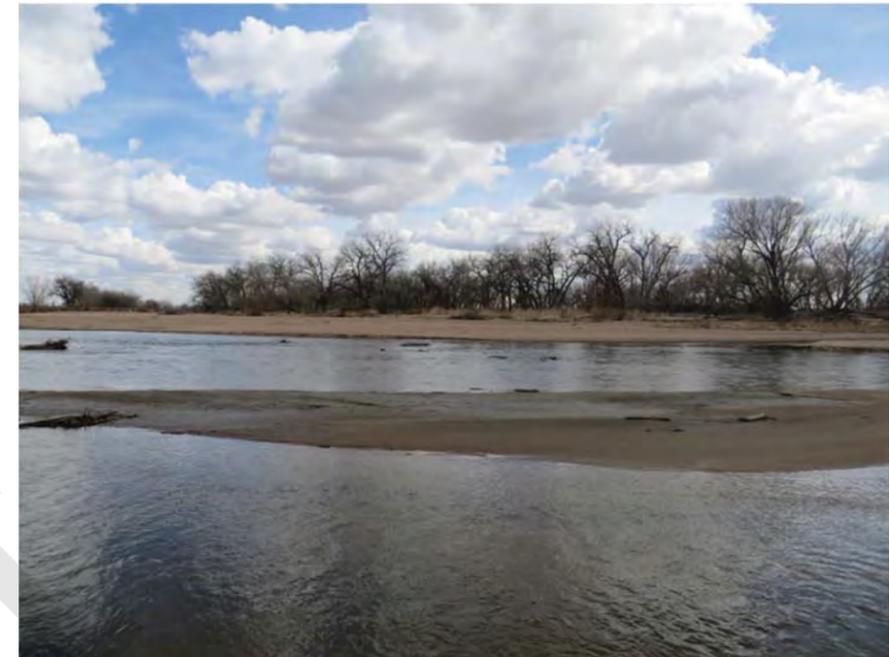
Photo 7.2 – Top of Reach 7, looking from the north bank to south bank, well developed point bar with a *P. deltoids* overstory and a small percent of shrub cover within the very thin riparian corridor.

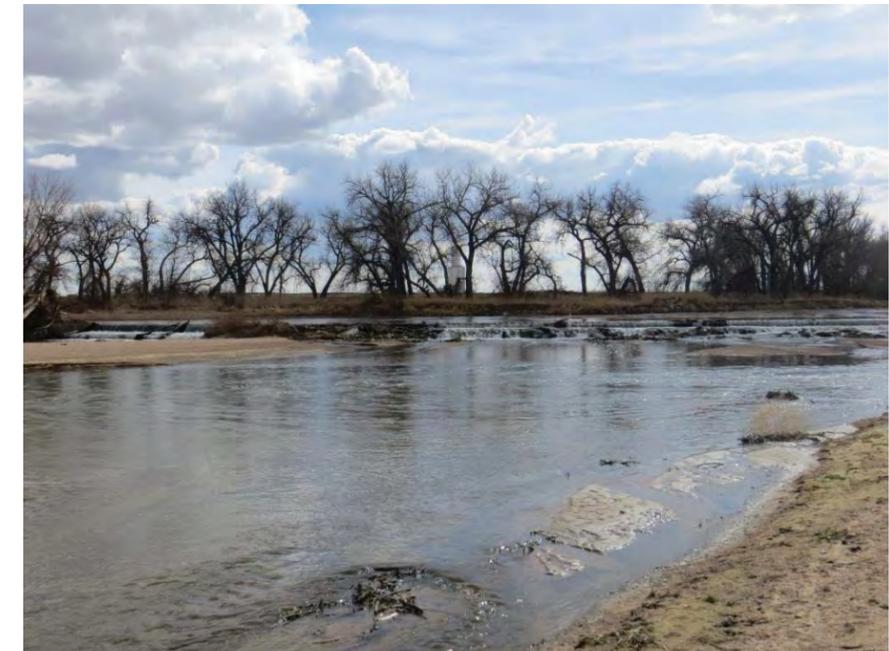
Photo 7.3 – Top of reach 7, looking upstream towards channel wide diversion structure. This structure and other diversions similar restrict aquatic species movement.

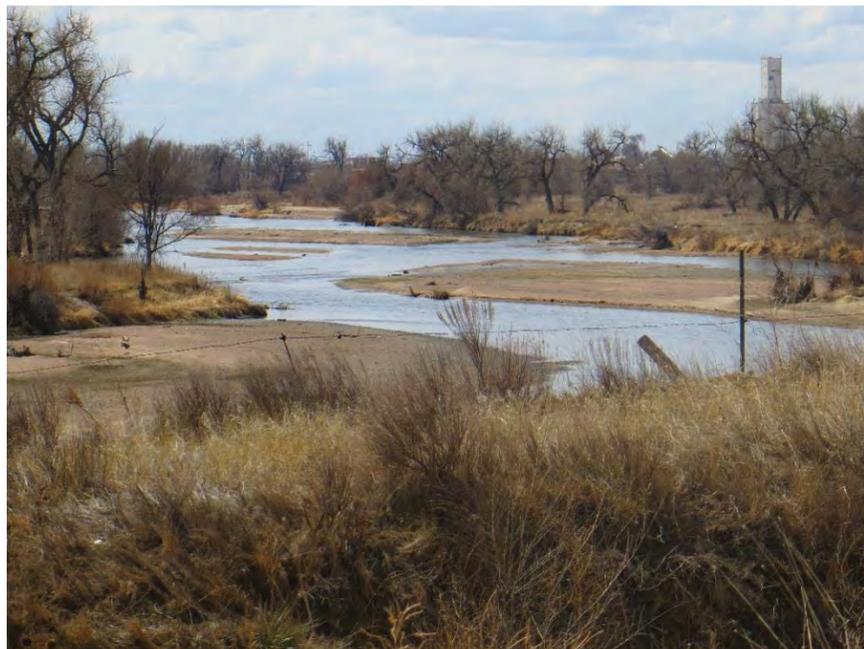
Photo 8.2 – Bottom of Reach 8, looking upstream from the south bank, a wide channel with meandering braids, possibly what the historic channel looked like.

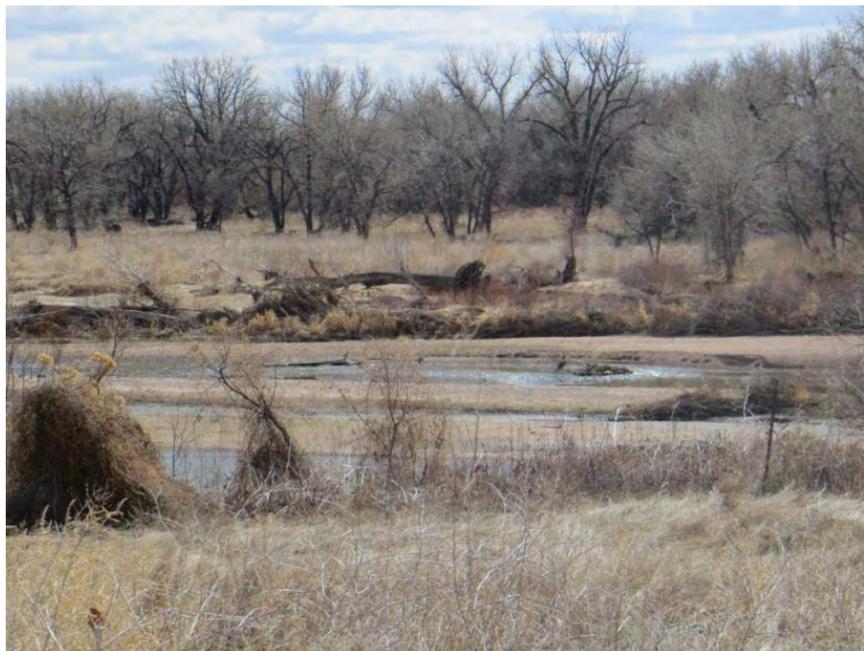
Photo 8.3 – Bottom of Reach 8, looking from the north bank to south bank, a wide riparian corridor with a good mix of *P. deltoids* overstory and woody understory. Woody debris is also along the bank and could provide future aquatic species habitat.

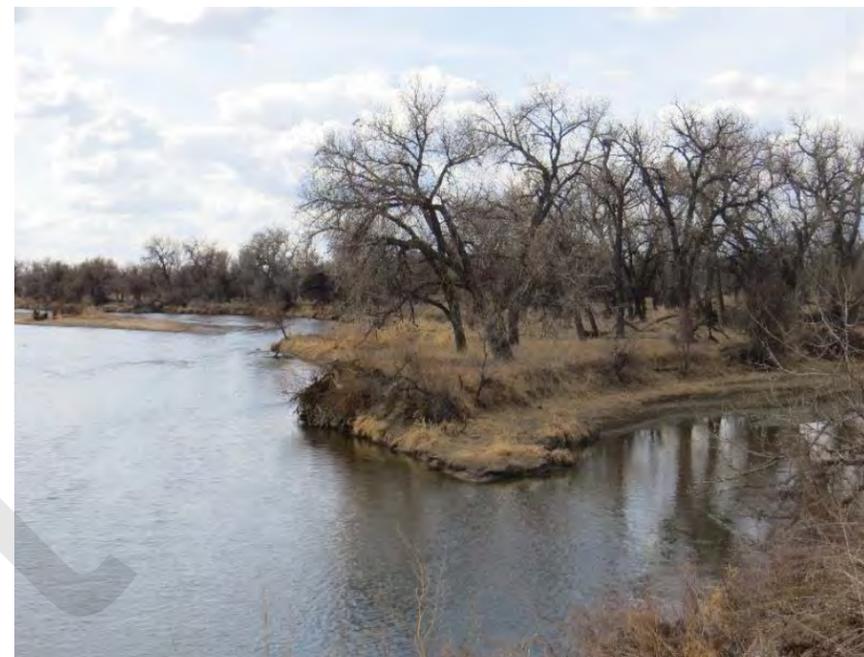
Photo 8.4 – Bottom of Reach 8, looking upstream from the north bank, confluence with Big Thompson River. Highly functioning riparian area and a high potential area for restoration activities.

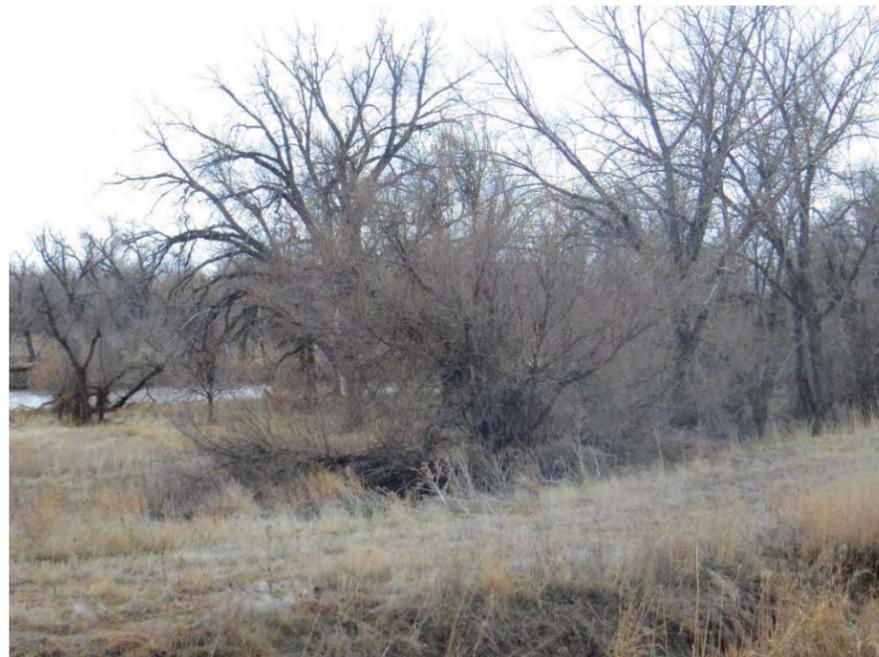
Photo 9.2 - Mid-Reach 9, north bank looking towards the river channel, irrigation canal in the foreground. South bank in back ground with a steep and bare bank.

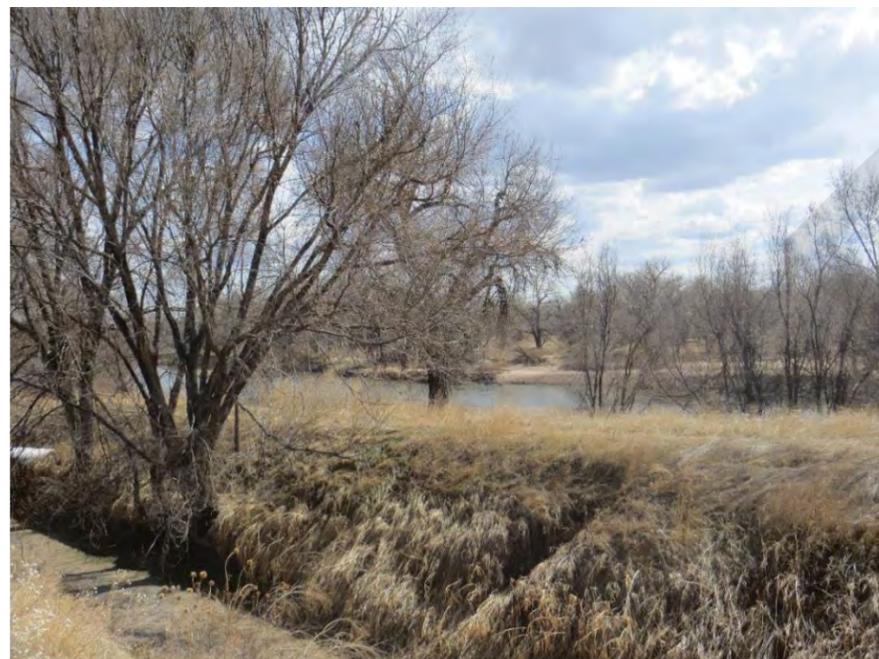
Photo 9.3 – Mid-Reach 9, looking from the north bank to south bank, the south bank has a fairly wide riparian corridor with a higher percentage of tree cover.

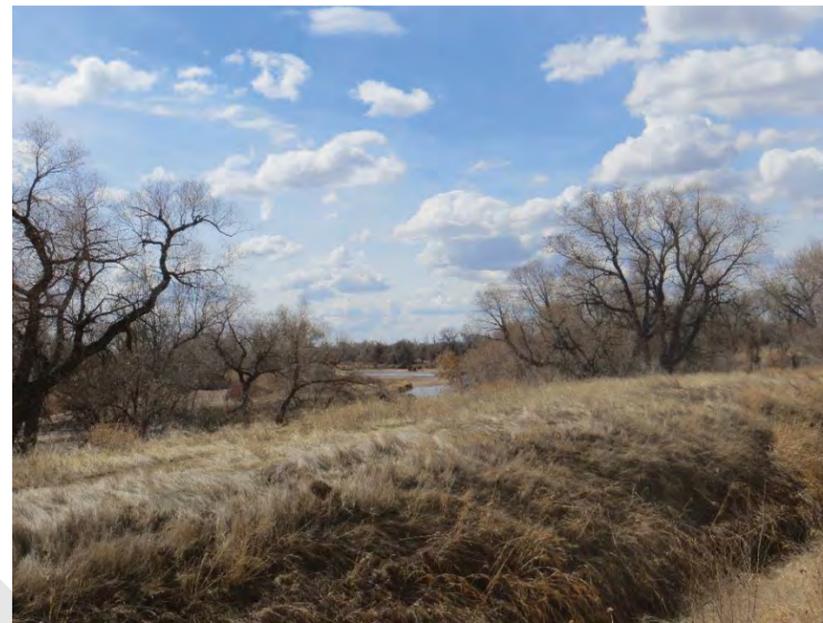
Photo 9.4 – Mid Reach 9, looking upstream from the north bank, large amounts of substrate present in the channel developing point bars and in-channel islands

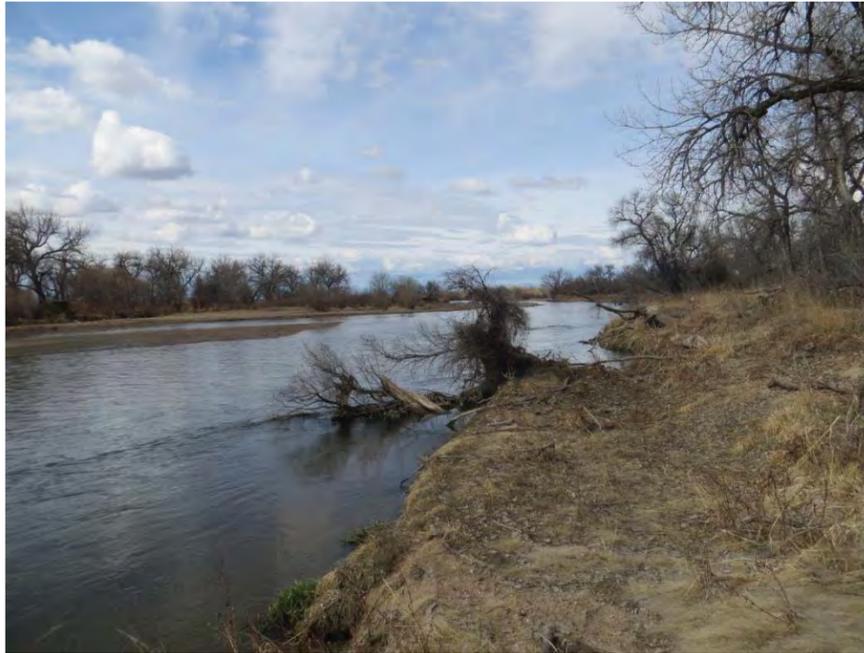
Photo 10.2 – Mid-Reach 10, looking upstream from the north bank, woody debris within the channel providing habitat opportunities for aquatic species. Banks are less incised and covered with herbaceous vegetation.

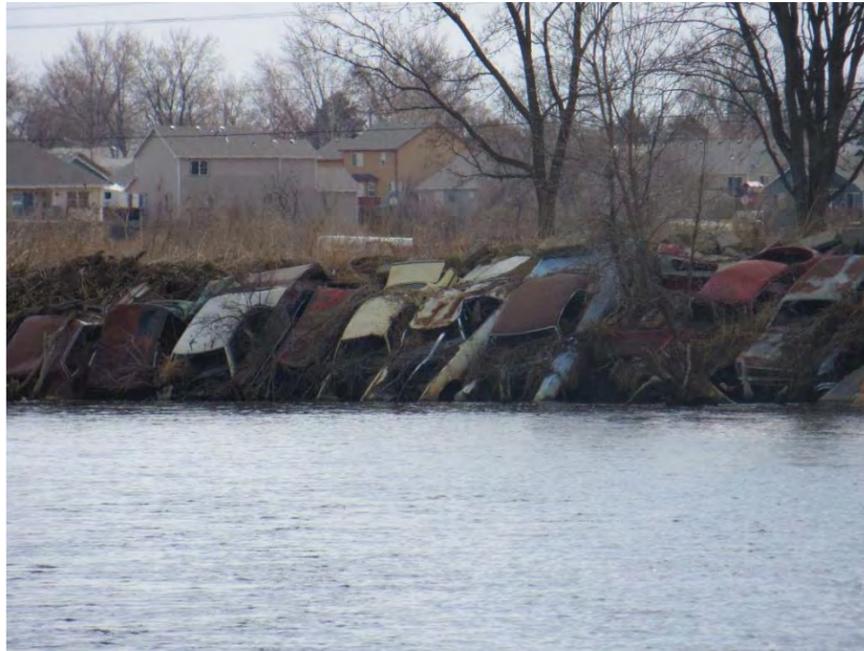
Photo 10.3 – Mid-Reach 10, looking from the north bank to the south bank, armored banks constructed from auto-bodies. The south bank in this piece of Reach 10 has little to no riparian with dense residential areas adjacent to the river channel along.

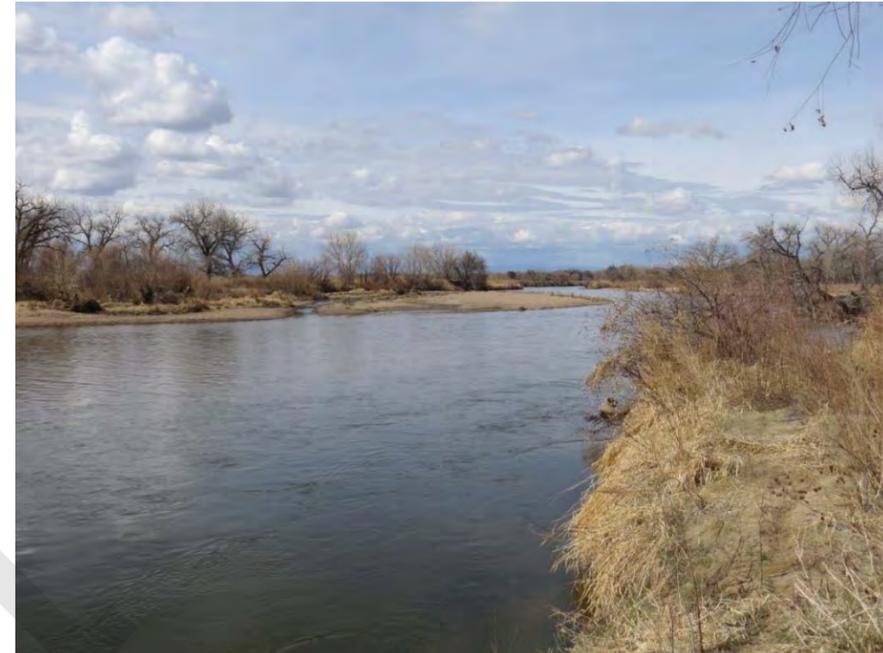
Photo 10.4 – Mid-Reach 10, looking upstream from the north bank. Banks are less incised and covered with vegetation, some woody species present, *Salix*, side channels are present along the south bank.
