South Platte River Restoration Master Plan

Prepared for:
City of Evans, Colorado

Prepared by:
CDM Smith

Appendix A

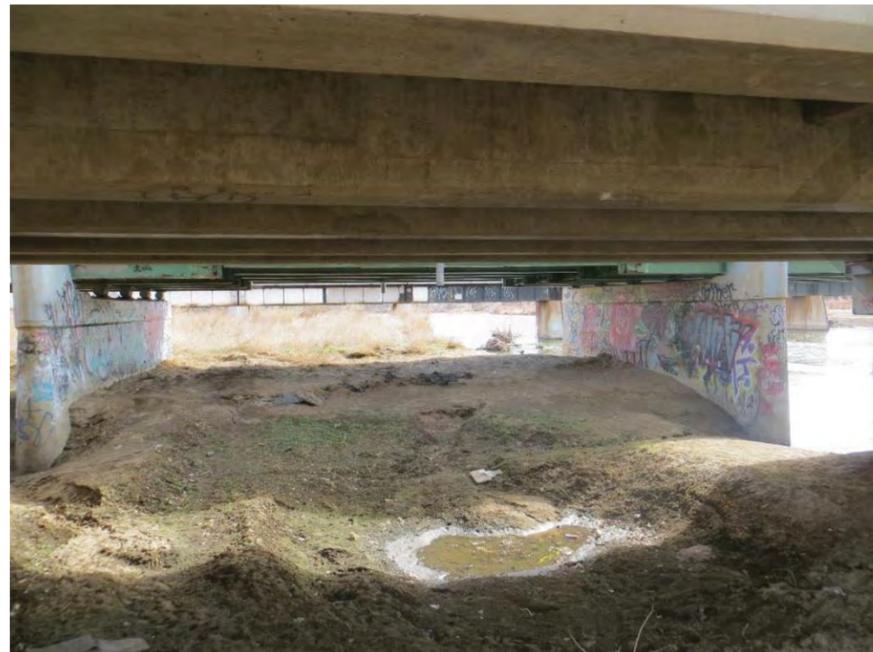
Photo 11.3 – Bottom of Reach 11, north bank under Highway 85 Bridge. Deposition of sediment due to three sets of bridge infrastructure in this area. Pools with algal growth were present within the sediment.

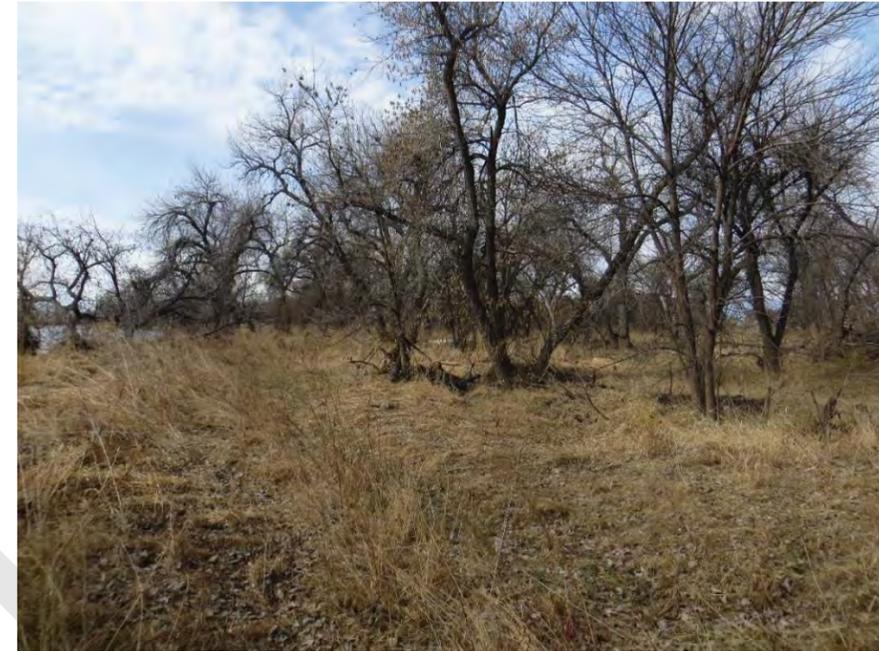
Photo 11.4 – Bottom of Reach 11, looking upstream on the north bank. Riparian forest along the north bank.

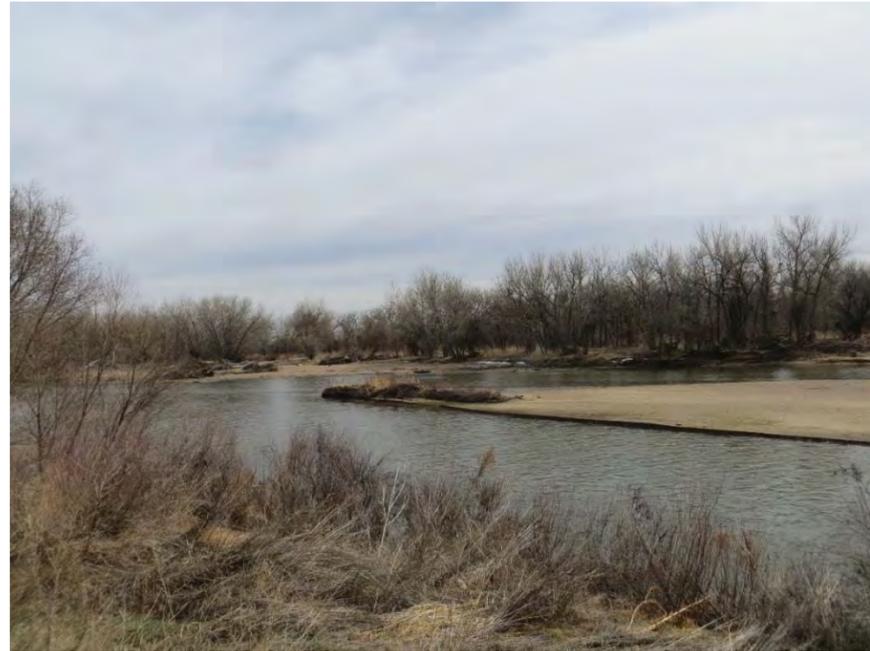
Photo 12.2 – Mid-Reach 12, Riverside Park looking from the north bank to the south bank. The riparian area on the north bank is thin with steep banks present, the channel is disconnected from the flood plain throughout this reach and large deposits of sediment within the channel.

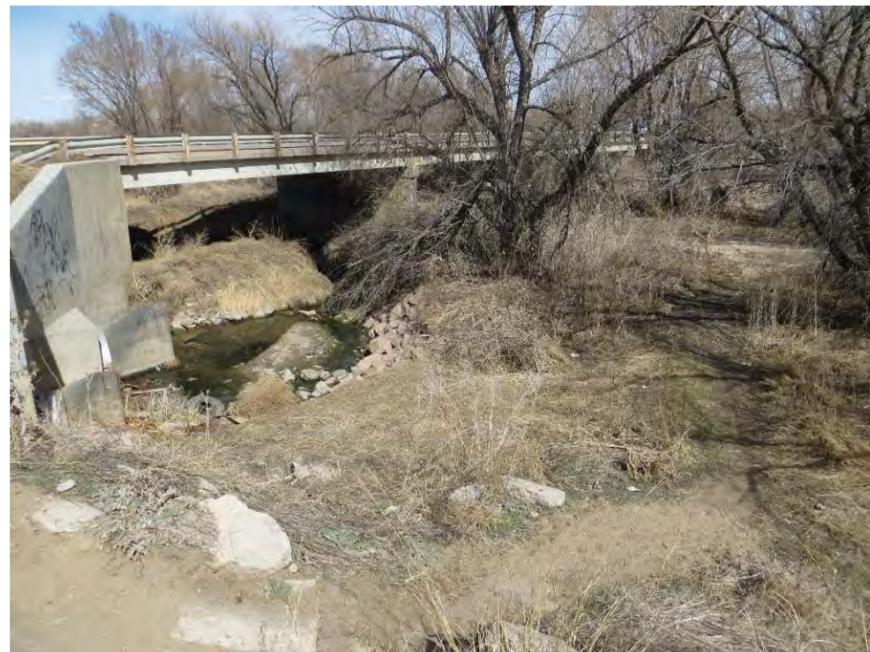
Photo 12.3 – Bottom of Reach 12, north bank, East 37th Street Bridge. Point source of nutrient enrichment and algal growth are present in this portion of the reach.

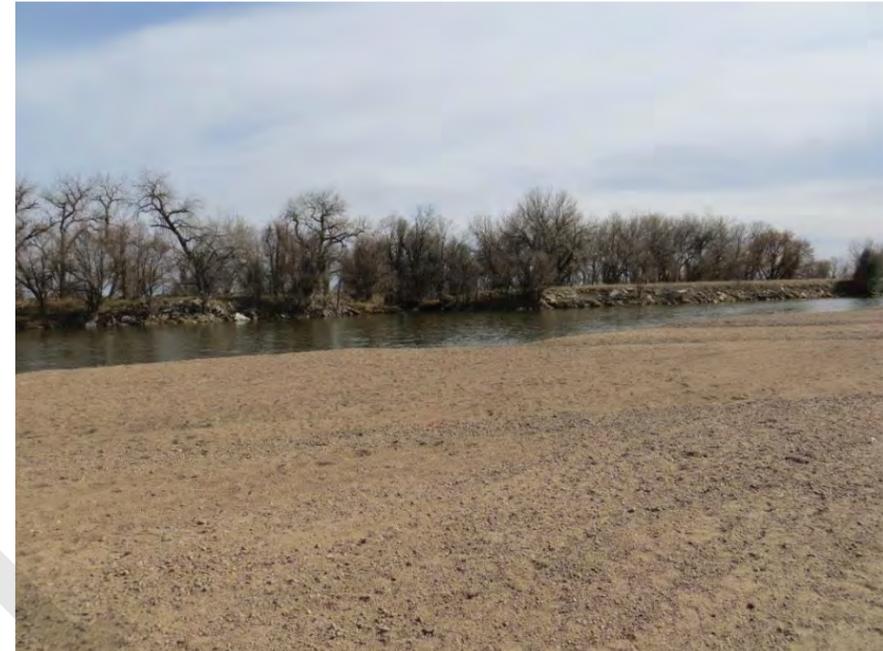
Photo 12.4 – Bottom of Reach 12 looking from the north bank to south bank. Deposition of sediment due to the East 37th Street Bridge infrastructure.

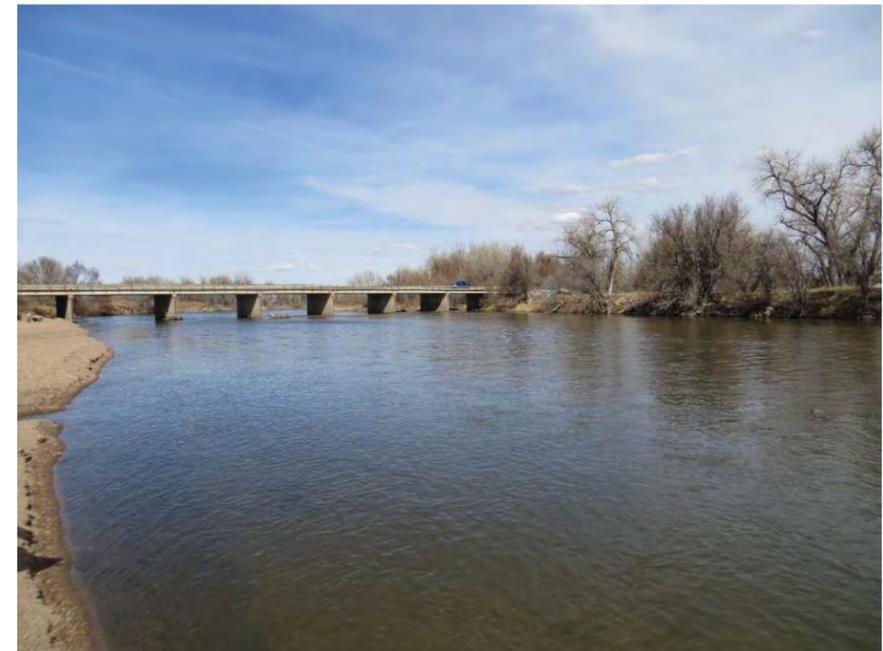
Photo 12.5 – Bottom of Reach 12 looking downstream towards the East 37th Street Bridge.

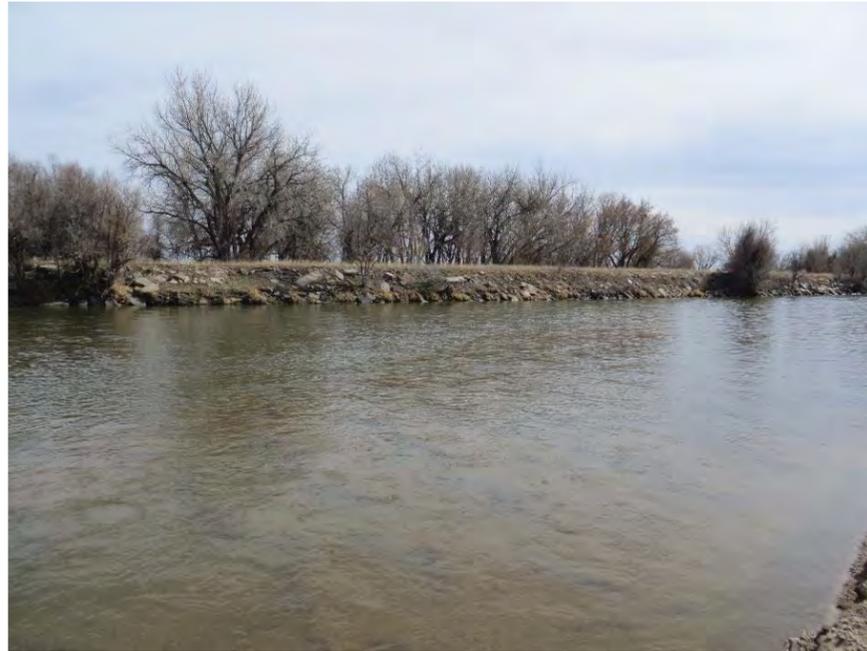
Photo 12.6 – Bottom of Reach 12, looking from the north bank to the south bank. This photo is an example of the heavily armored banks throughout this reach and the degree of separation between the floodplain and channel.

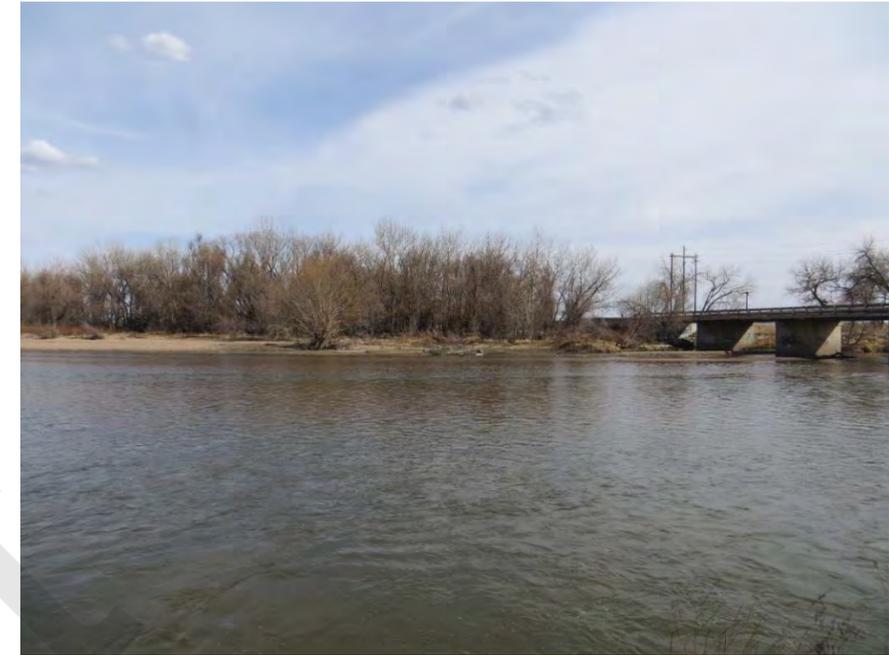
Photo 13.2 – Top of Reach 13, looking from the north bank to the south bank. Deposition of sediment below the East 37th Street Bridge making the channel wide, shallow, and homogenous with little diversity of habitat for aquatic species.

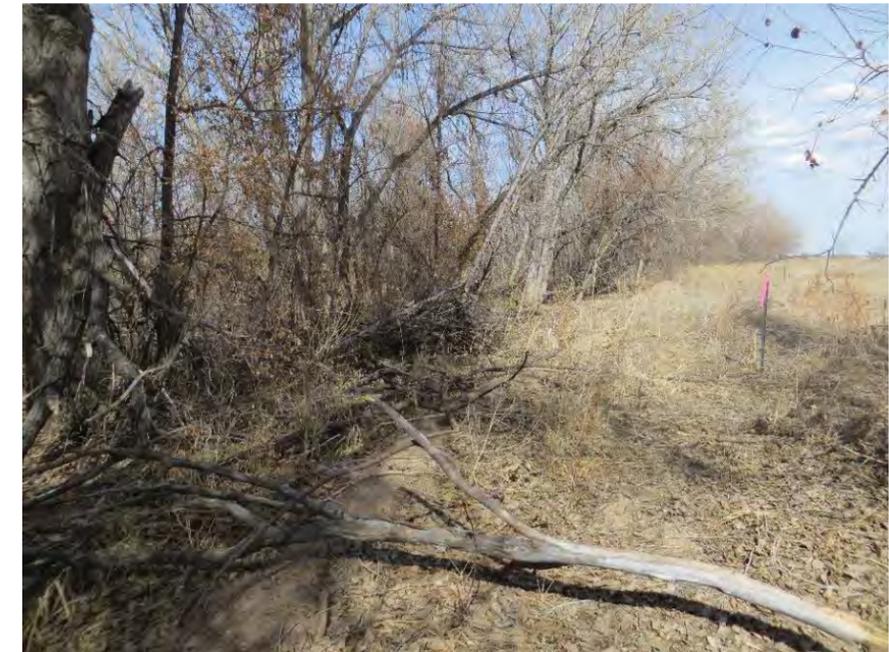
Photo 13.3 – Top of Reach 13, south bank looking downstream on the edge of the riparian. This is located within Brower State Wildlife area and could be a promising location for restoration activities.

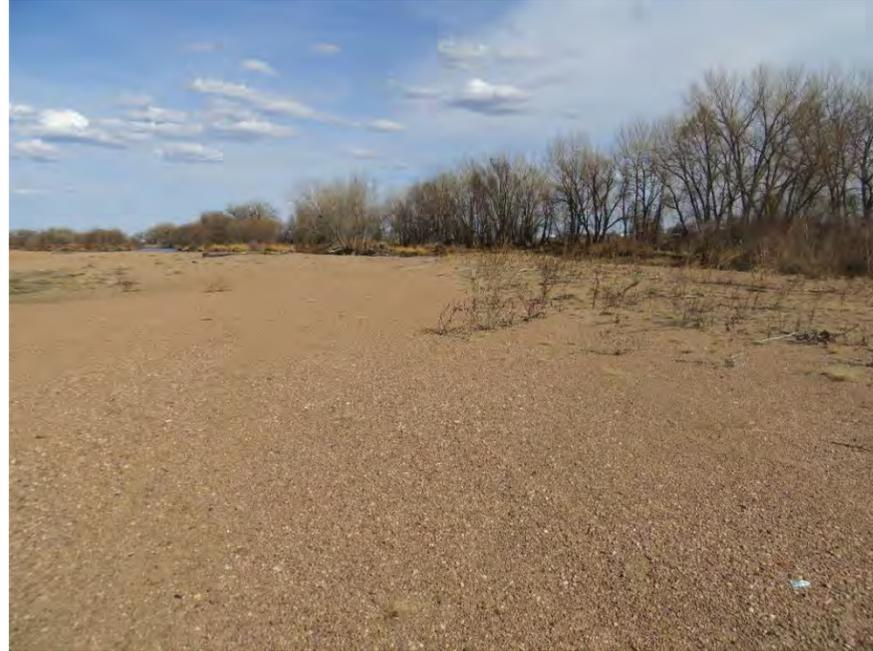
Photo 13.4 – Top of Reach 13, looking downstream on the south bank. Large depositional bar of sediment below the East 37th Street Bridge. In the distance there are islands with a healthy mix of herbaceous and woody cover with some regeneration.

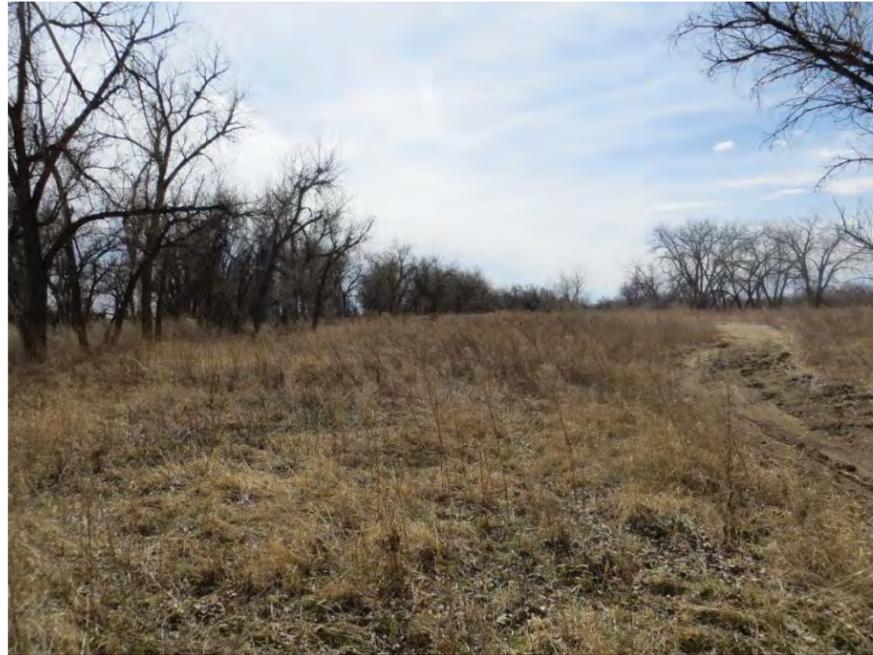
Photo 14.2 – Near the bottom of Reach 14 on the south bank, looking upstream. The riparian corridor is patchy and thin in this part of the reach, however the north bank riparian corridor is denser.

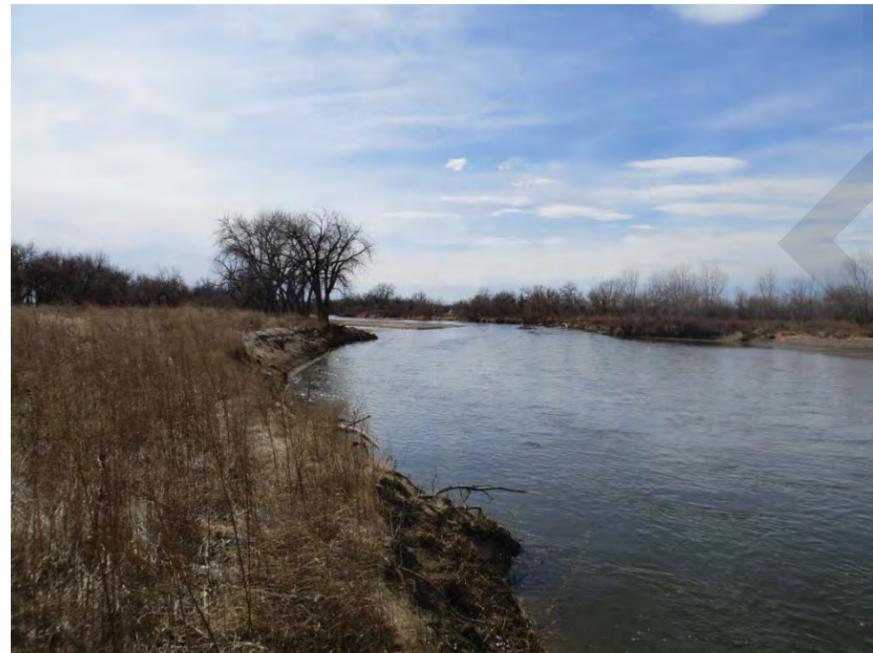
Photo 14.3 – Near the bottom of Reach 14 on the south bank, looking upstream. This reach contains a wide homogenous channel with little habitat for aquatic species.

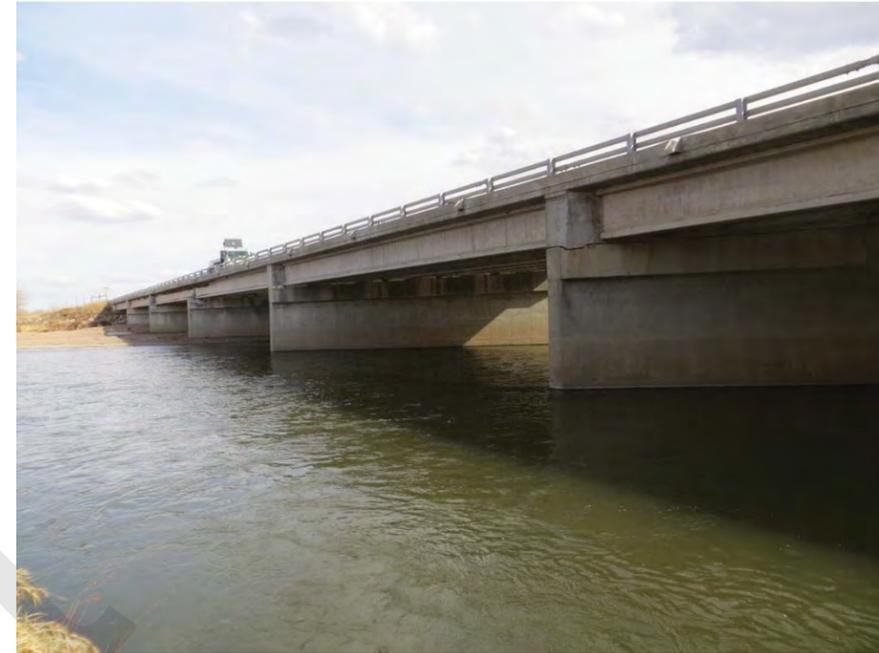
Photo 15.2 – Top of Reach 15, looking from the north bank to the south bank. Highway 34 Bridge.

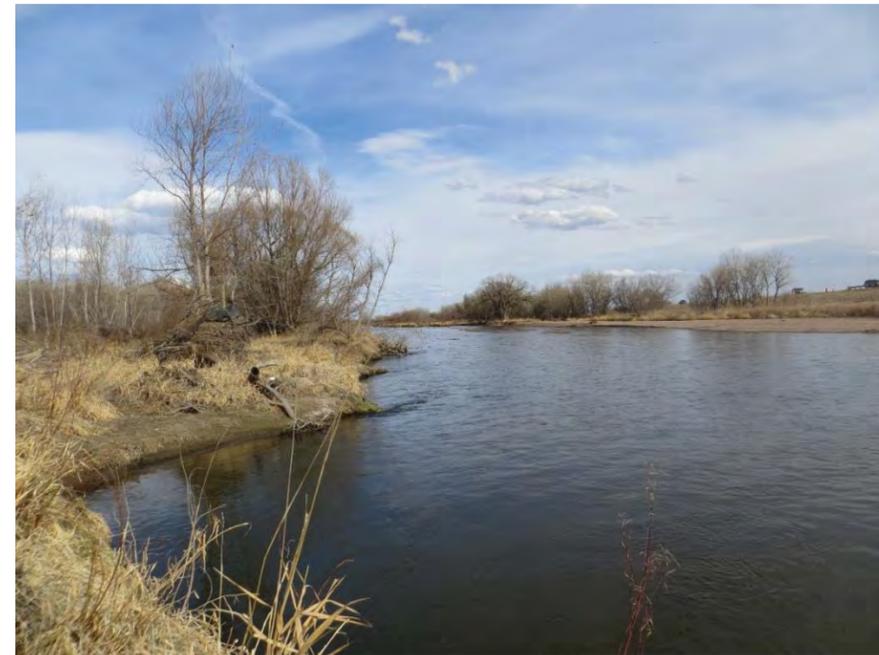
Photo 15.3 – Top of Reach 15, looking downstream along the north bank. The banks in this reach are less steep and generally have better cover than most. The north corridor riparian however is a little thin.

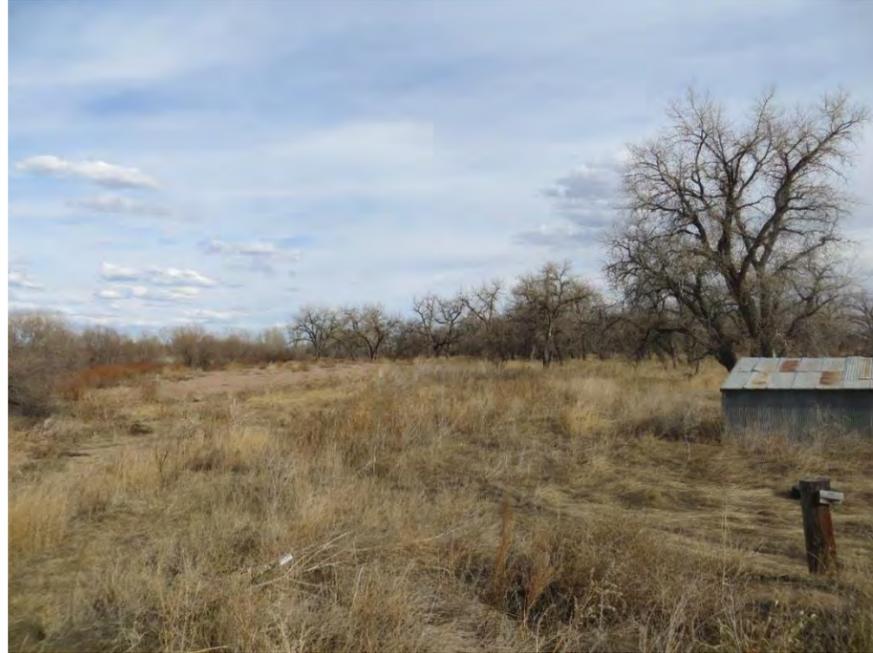
Photo 16.1 – Top of Reach 16, looking downstream, along the south bank riparian corridor. The riparian is wider on the south bank and has a mix of declining *P. deltooides* overstory and woody shrub component along the edge of the river.

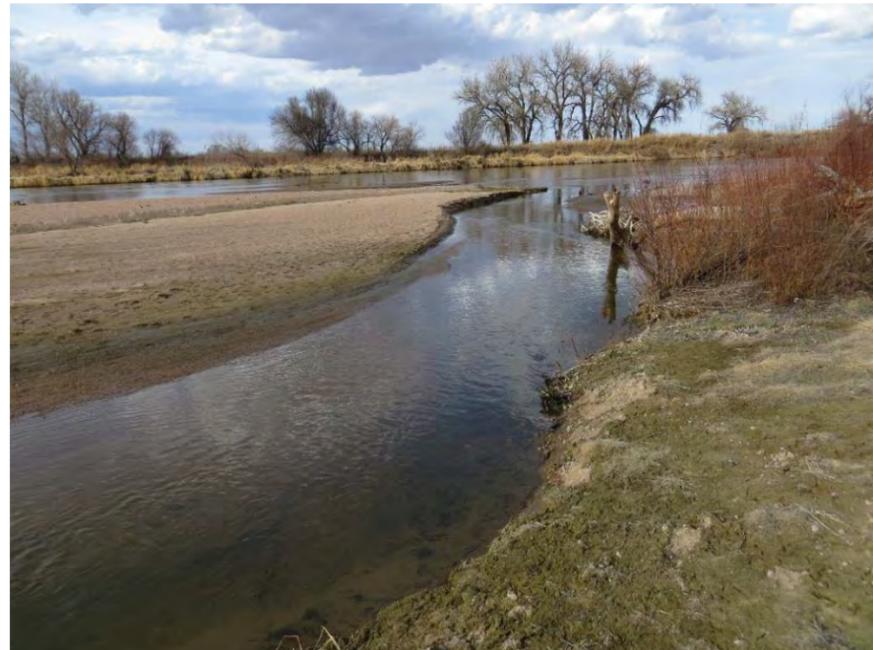
Photo 16.2 – Near the top of Reach 16, looking downstream along the south bank. This reach contains a better diversity of aquatic species habitat.

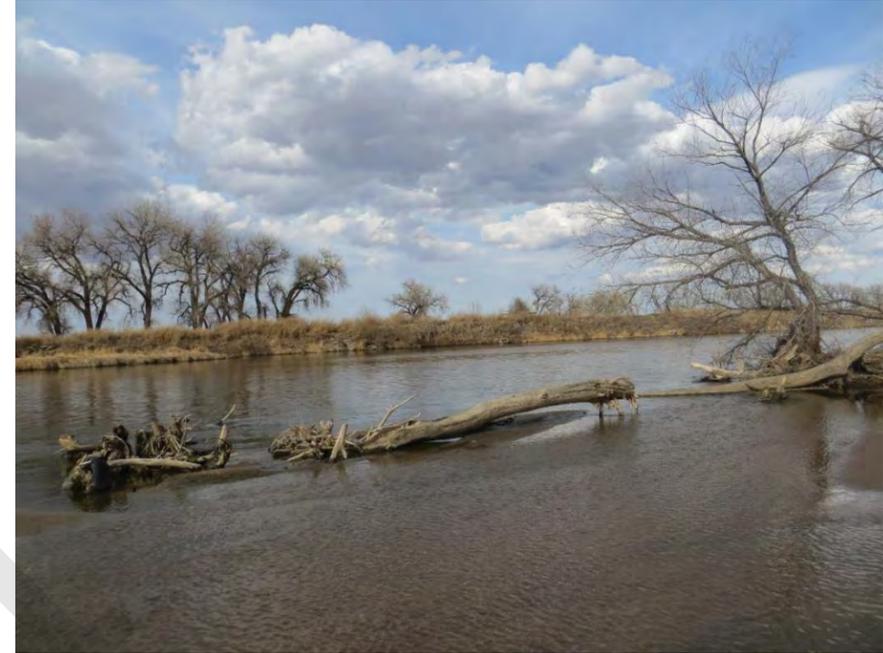
Photo 16.3 – Near the top of Reach 16, looking from the south bank to the north bank. More examples of aquatic habitat diversity are in the foreground. In the background the thin and patchy riparian corridor is visible.

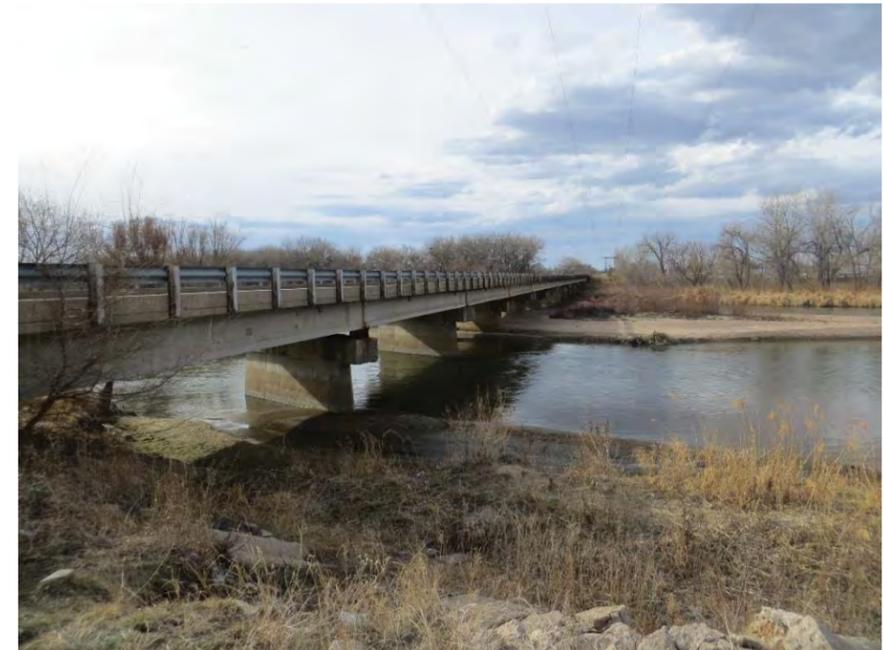
Photo 16.4 - Top of Reach 16, looking across from the south bank to the north bank. Highway 34 Business Loop Bridge.

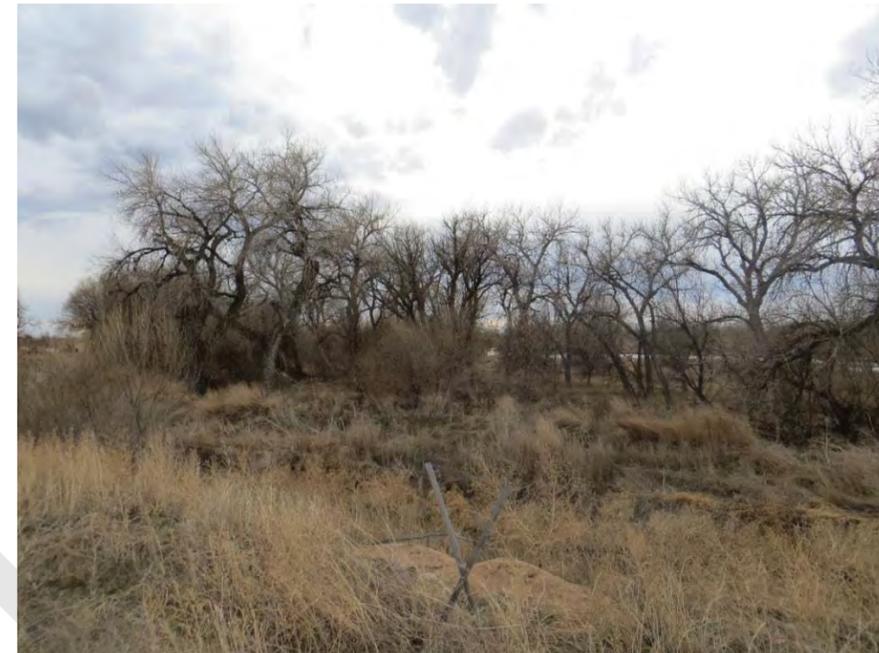
Photo 18.2 – Top of Reach 18, looking from the outer edge of the south bank riparian corridor towards the river. The riparian is fairly thin and patchy with little regeneration.

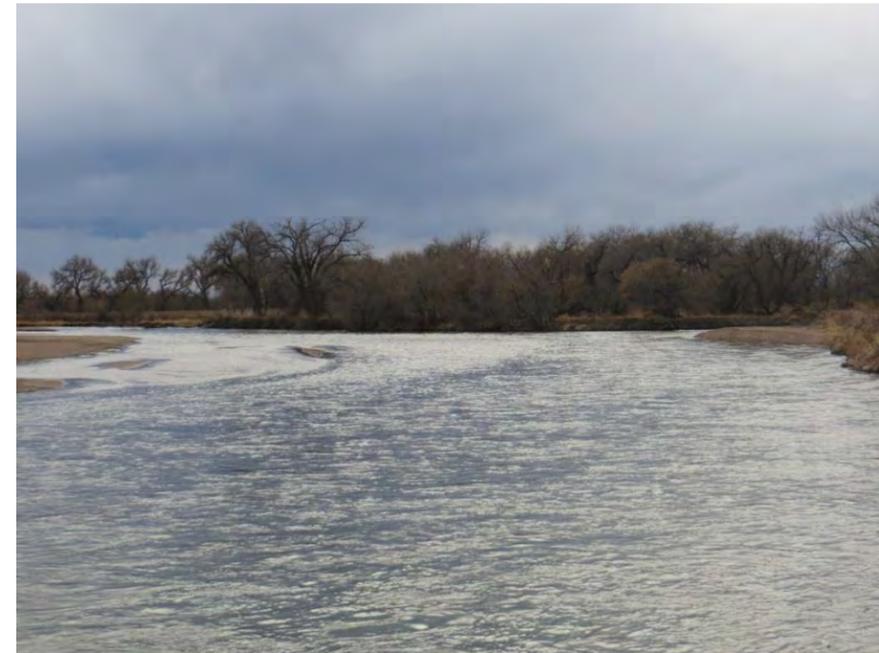
Photo 18.3 – Bottom of Reach 18, looking upstream from the north bank. The confluence with the Cache La Poudre River is on the right side of the photo.
